Philips Norelco BG2040 BodyGroom 7100 Trimmer Head Blades Replacement

Disassemble and replace trimmer head blades in the Philips Norelco Bodygroom series 7100.

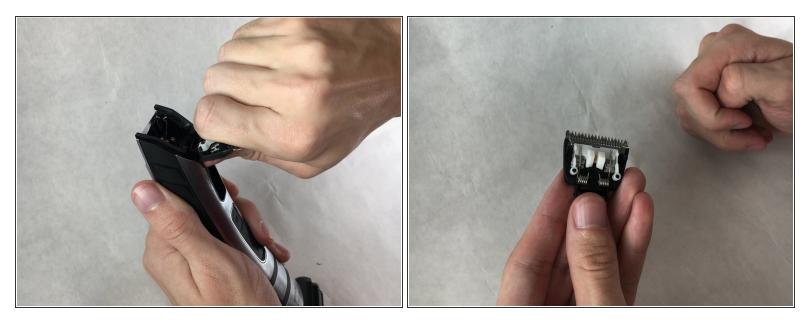
Step 1 — Trimmer Head Blades

- Pop open the trimmer head by pushing against the blades.
- Slide off trimmer guard and open the hatch on the side.
- Remove the trimmer from the base.

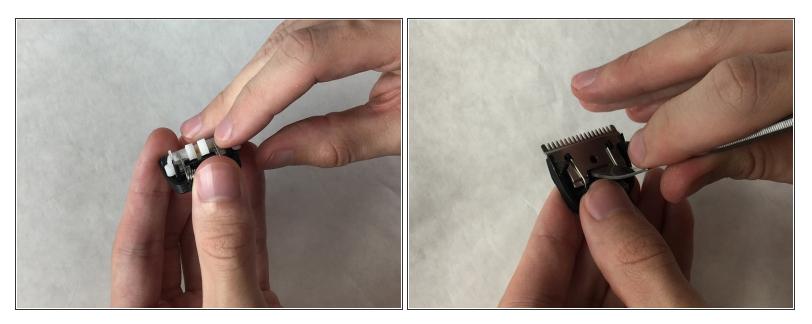
Step 2

- Remove spring first, and then pull off white plastic along with the first, moving blade.
- Use spudger to pry off second, stationary blade.

To reassemble your device, follow these instructions in reverse order.
