Tonneau Trifold Bed Cover Retention Pin Replacement

Written By: Christopher King

INTRODUCTION

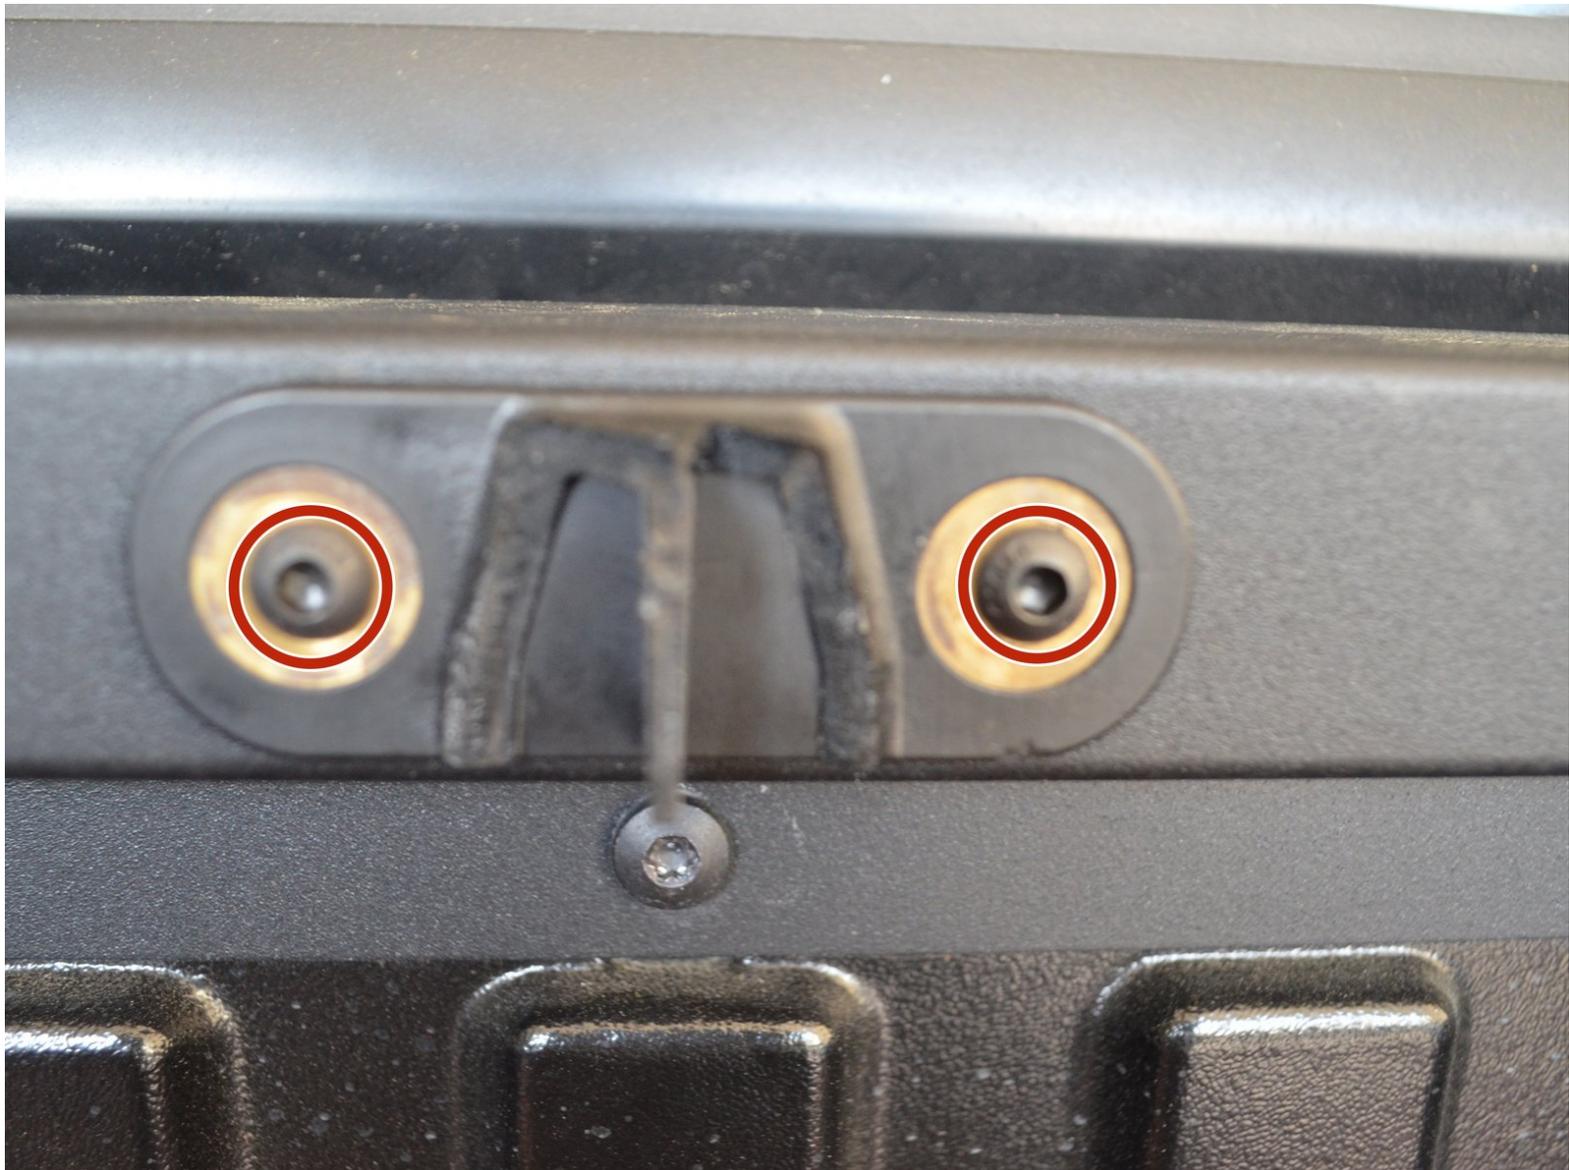
The retention pin on a Tonneau cover keeps the bed of your truck sealed . If your Tonneau cover no longer closes due to a broken retention pin, follow this guide to replace it in your 2016 Toyota Tacoma with Tonneau Trifold Bed cover. You need to replace your retention pin to make sure your bed cover is safely closed and your items in the back of you truck are well kept . This job does not require any special tools.

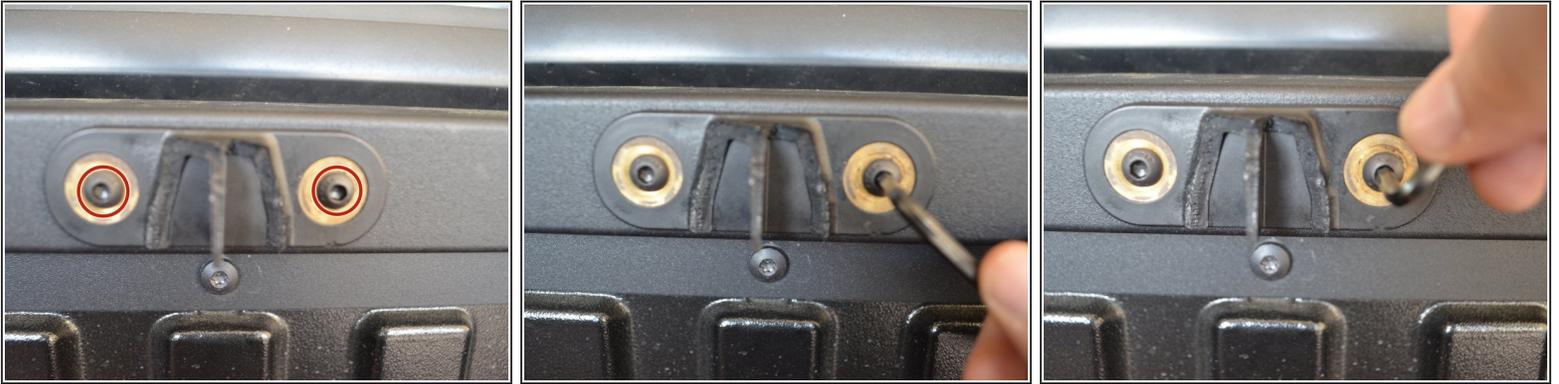
Step 1 — Retention Pin

- Locate the two screws on the retaining latch.
- Use an Allen Wrench to loosen the screws.
 - ⓘ The screws are tight and may require significant force.

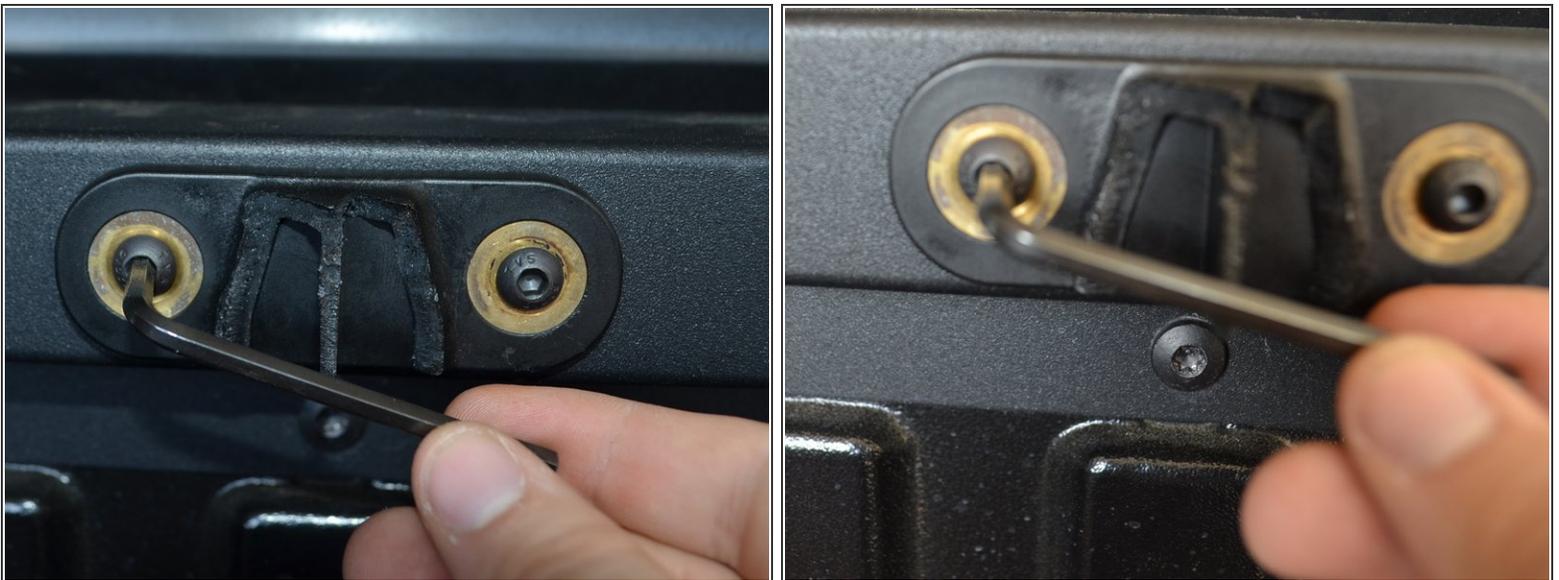
Step 2

- Continue loosening the screws until they are both loose enough to remove by hand.

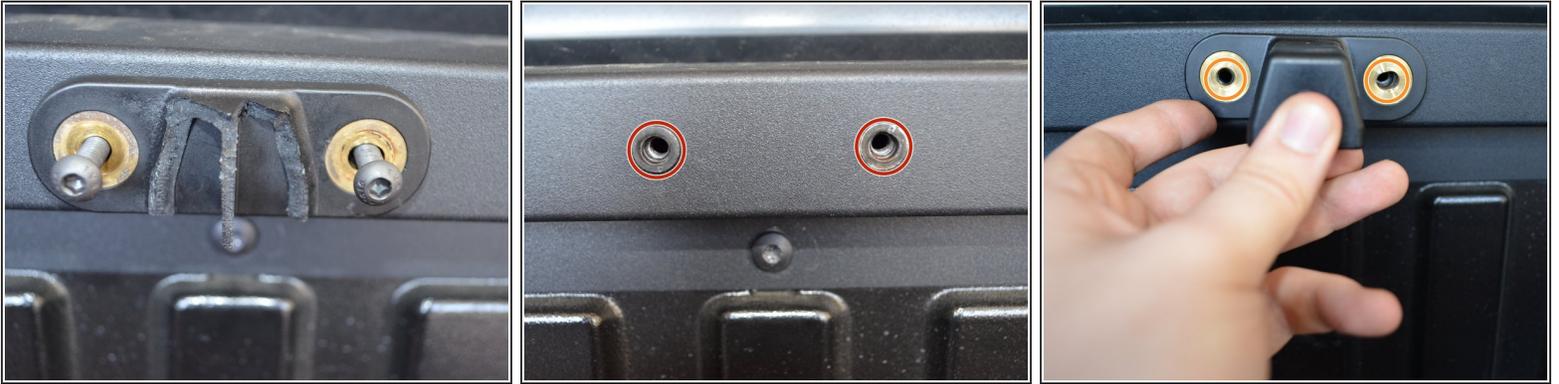
Step 3

- Grab both screws and pull them straight out.
- Line up the holes on the replacement latch, then insert the new screws.

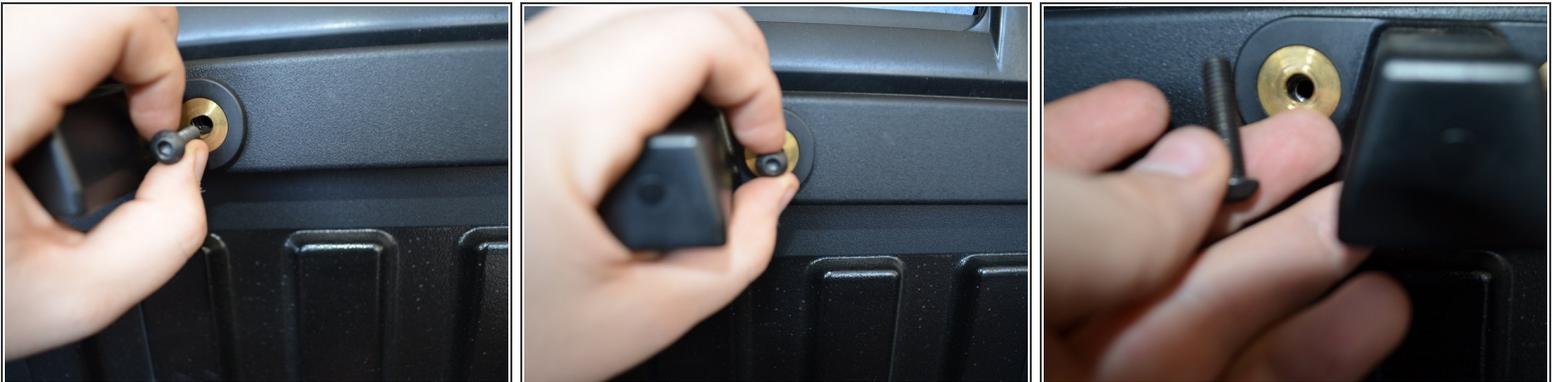
Step 4

- Hand tighten both of the bolts onto the new latch.

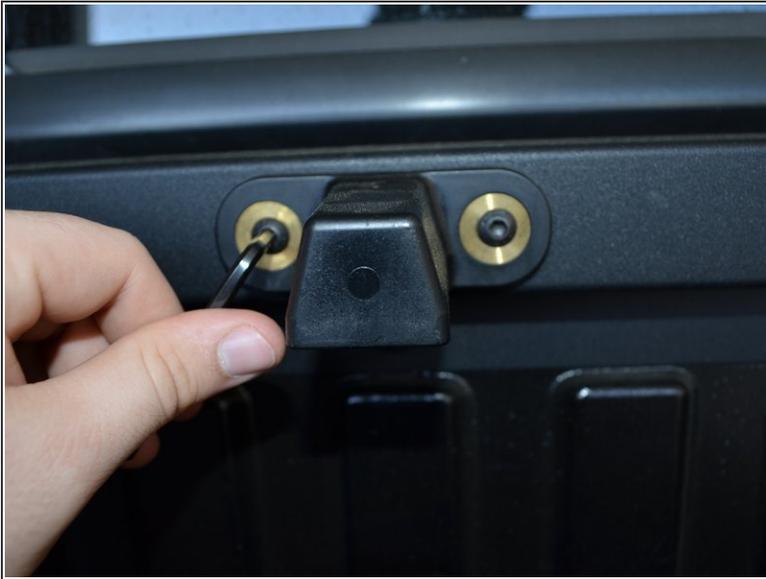
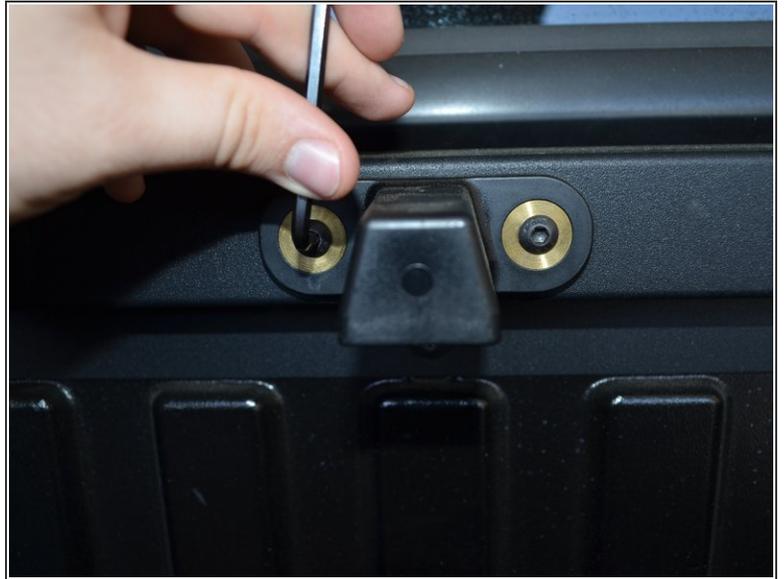
Step 5

- Tighten both screws evenly until the latch is held firmly in place.

⚠ Do not over tighten - you could break the Allen Wrench or strip the screws!
