Pioneer MXT-X366BT Metal Case Replacement

This guide details how to remove and replace the metal sleeve surrounding the radio.

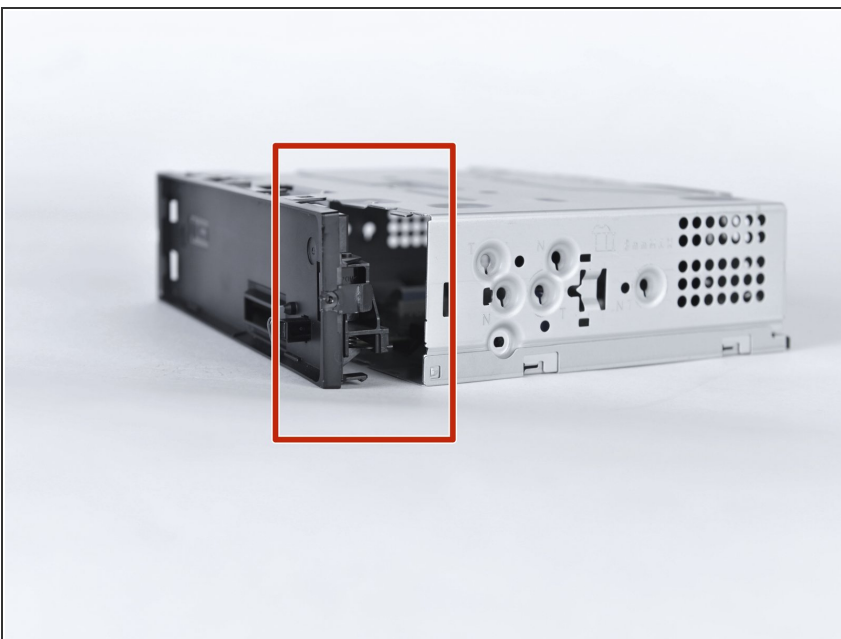
Step 2

- Remove the face plate holder.

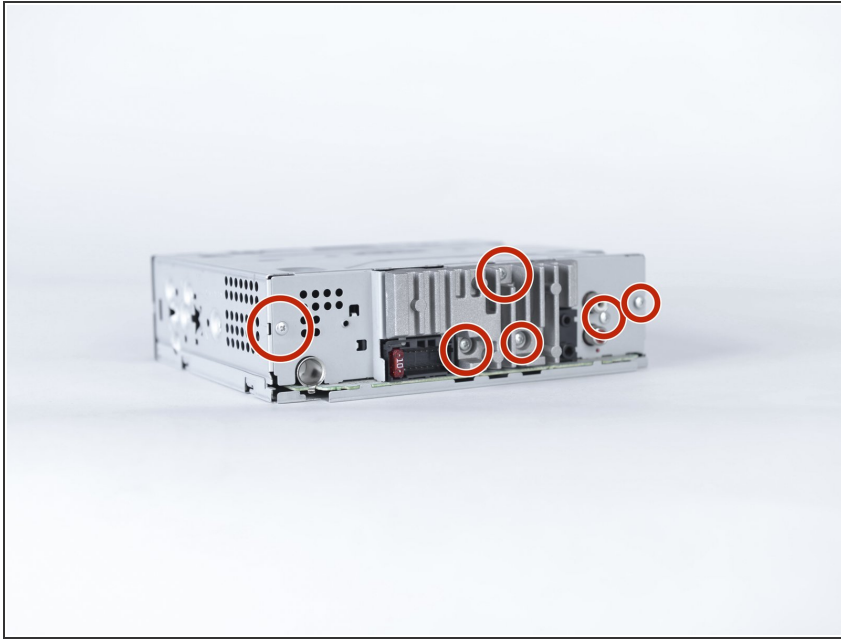
Step 3

- Remove the six 5mm Phillips-head screws with Philips #2 screwdriver.
