Asus Chromebook C202 Metal Bracket Replacement

This guide will provide a brief summary to replacing the Metal Bracket in an Asus Chromebook C202.

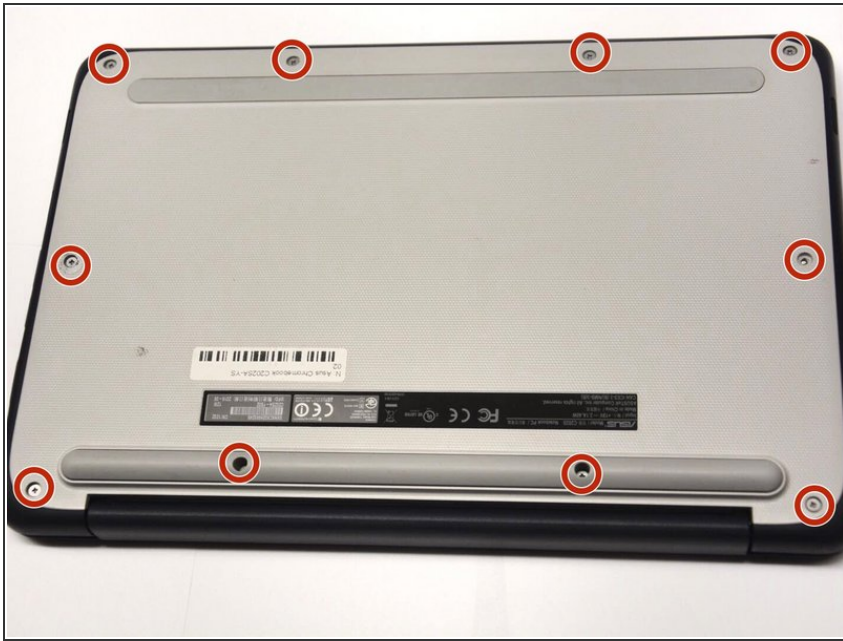
Step 1 — Palm Rest

- Turn the device over so the bottom is facing up.
- Remove the ten Phillips #1 8.0 mm screws.

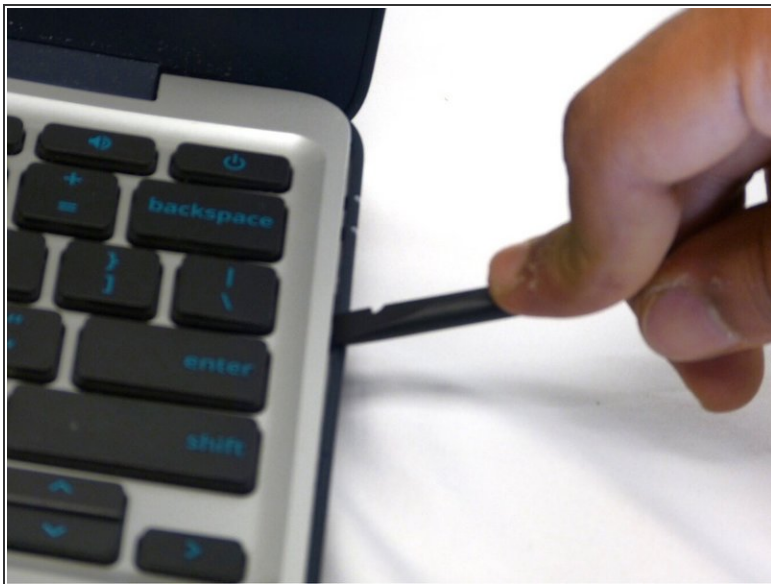
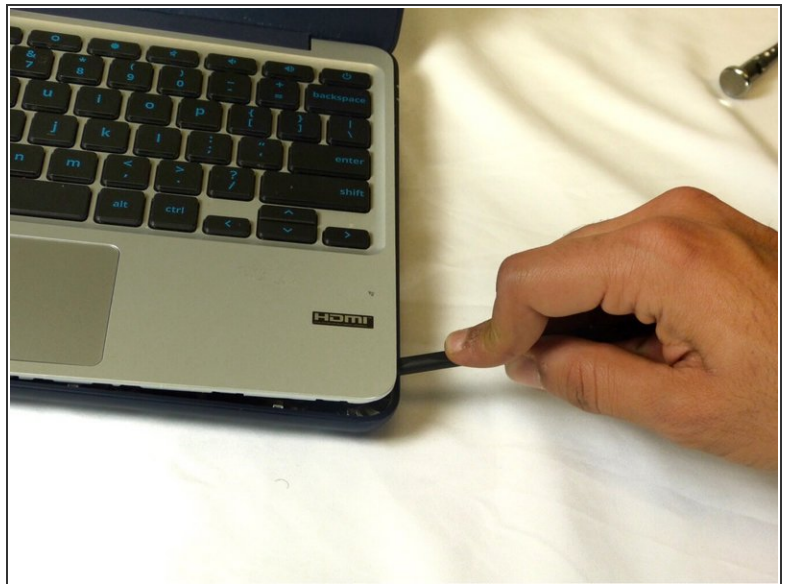
Step 2

- Carefully use the plastic opening tool to pry the palm rest apart from the bottom cover. Start from one spot and systematically work your way around until the whole palm rest is detached.

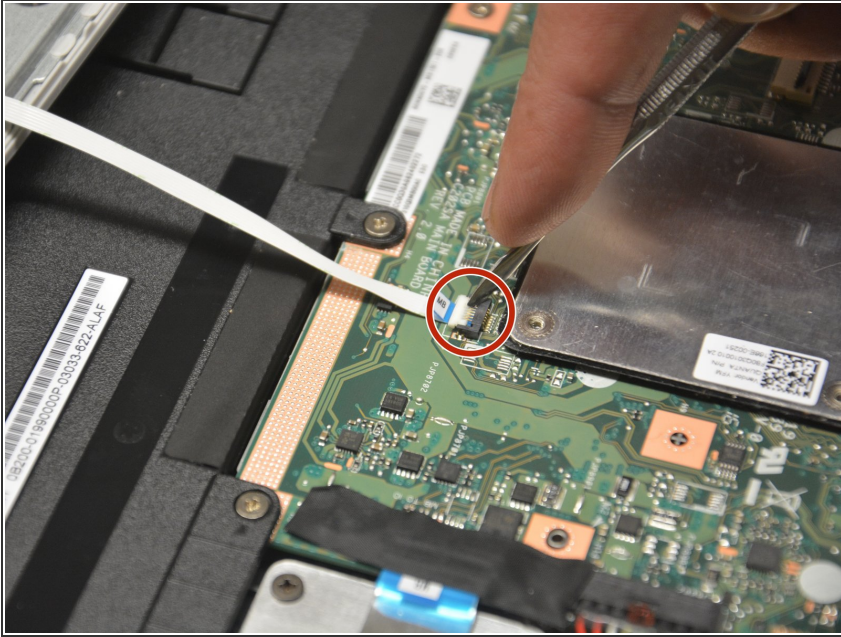
Step 3

- Disconnect the two cables that run from the keyboard to the motherboard and from the touch pad to the motherboard.
- ⓘ You may have to use a spudger to lift open the respective latches.

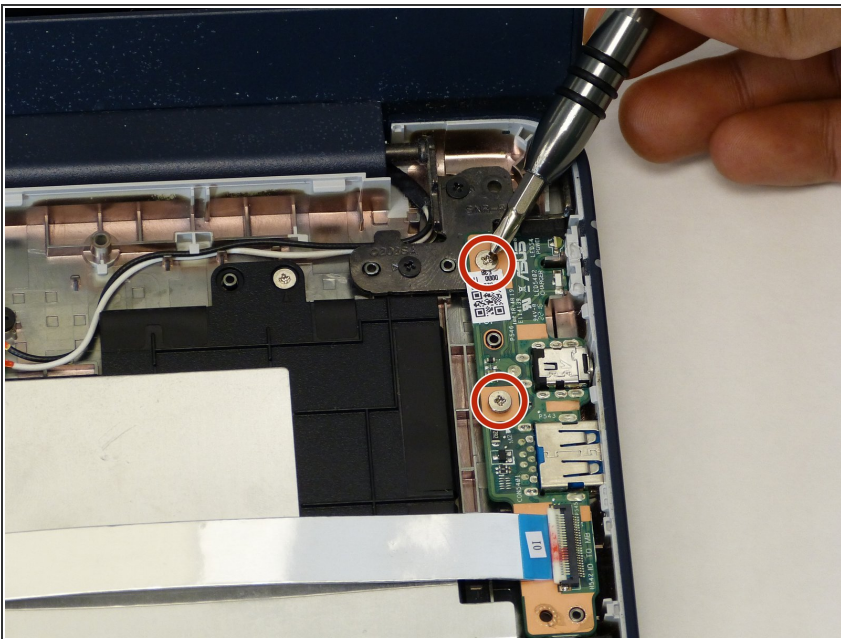
Step 4 — Daughterboard

- Remove both Phillips #1 4.5 mm screws from the daughterboard.

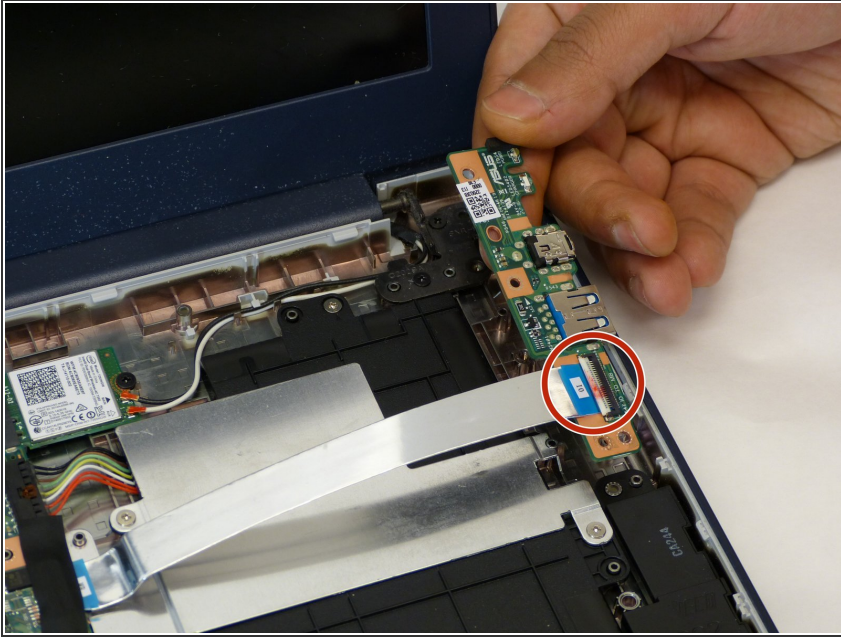
Step 5

- Gently remove the thin band from the daughterboard. You may have to use a thin blade or spudger to lift the silver clip to release the band.

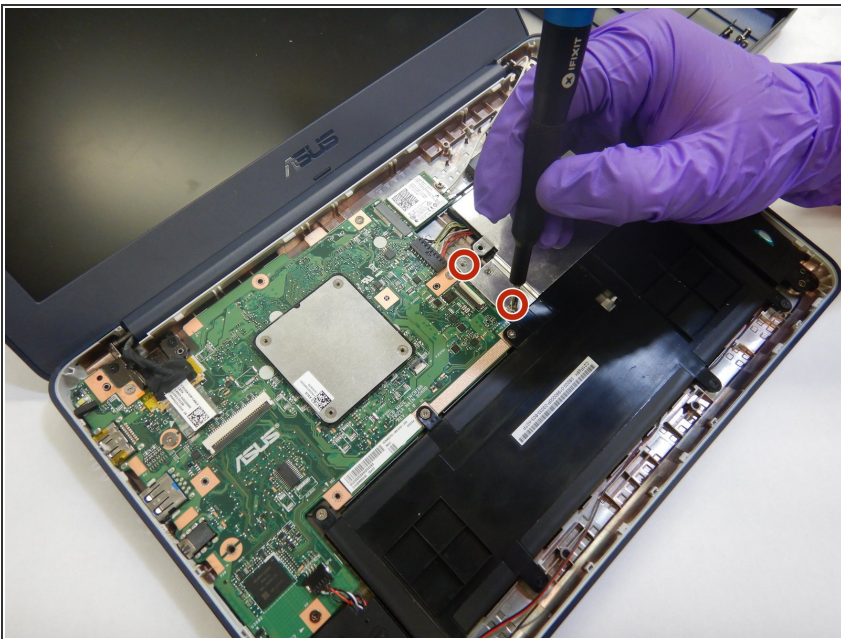
Step 6 — Metal Bracket

- Use a Phillips screwdriver to remove three 4 mm Phillips #1 screws from the metal bracket.

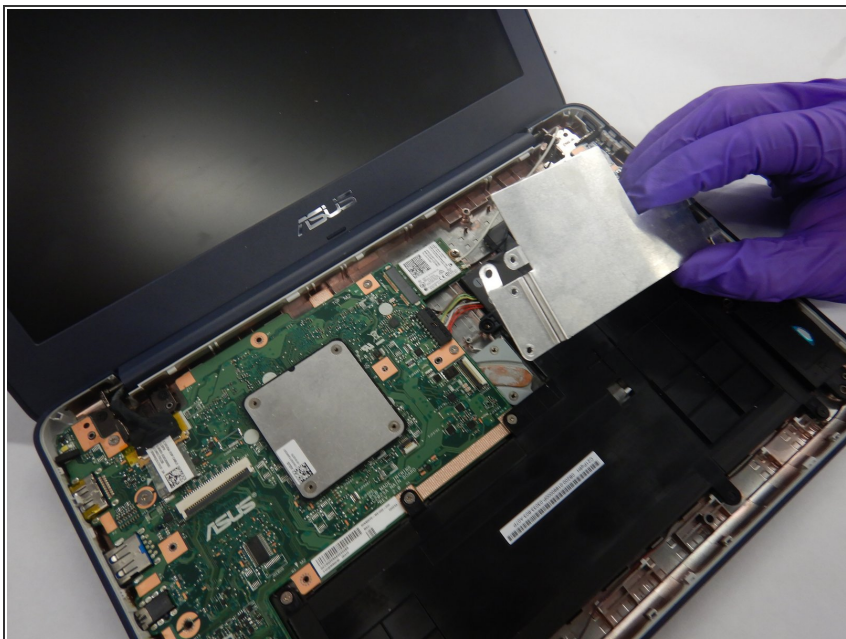
Step 7

- Once all the screws are removed the metal bracket can be disconnected from the motherboard.
- Remove the metal bracket.
