Vixen 21 Oil Cooler Replacement

Replacing the leaking stock oil cooler and hose with an aftermarket cooler and hoses from AFAB.

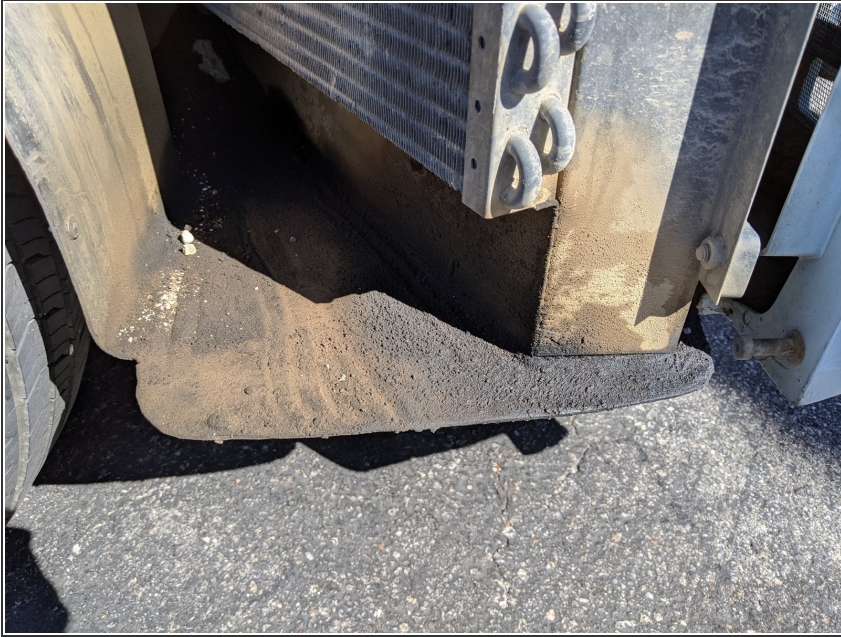
Step 1 — Oil Cooler

- After removing the side panel, it's clear that my oil cooler has been leaking for a while. Fortunately, AFAB sells a [complete replacement kit](#) including a new oil cooler and new hoses!

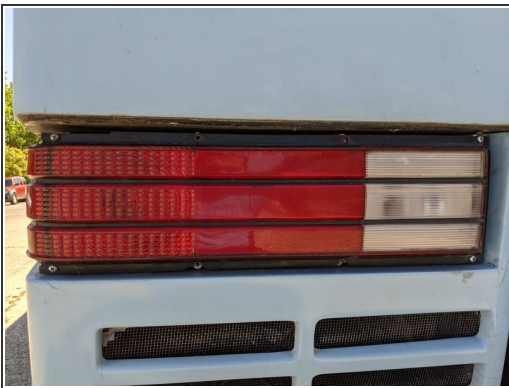
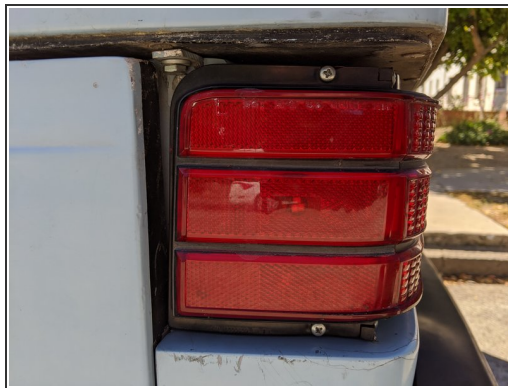
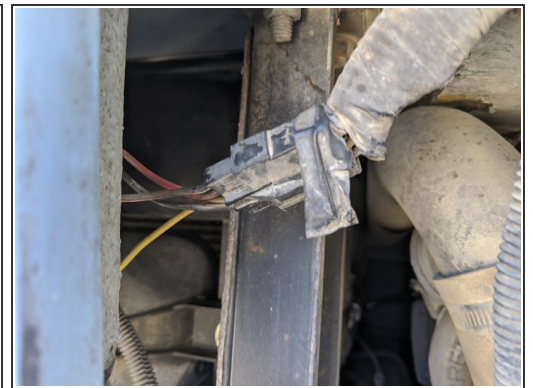
Step 2

- The tail light covers come off easy enough with 10 screws and a single connector.
- The white housing beneath comes off with a bolt on the left and a screw on the right.

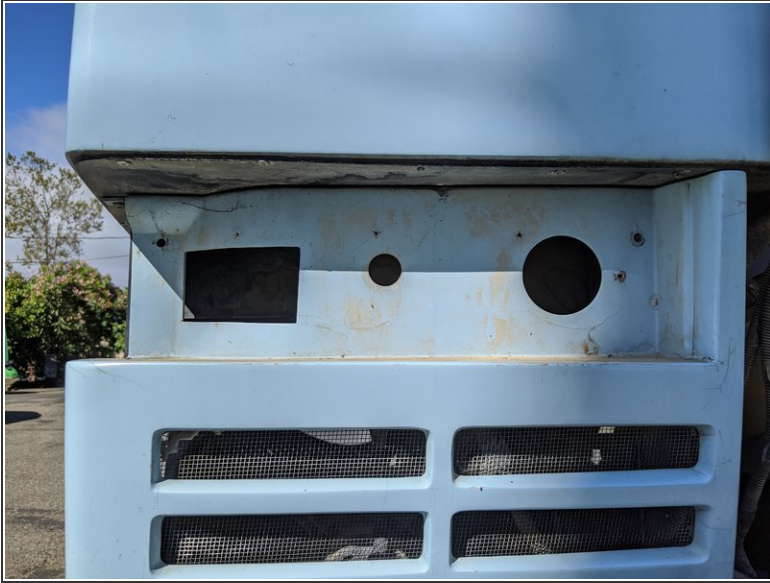
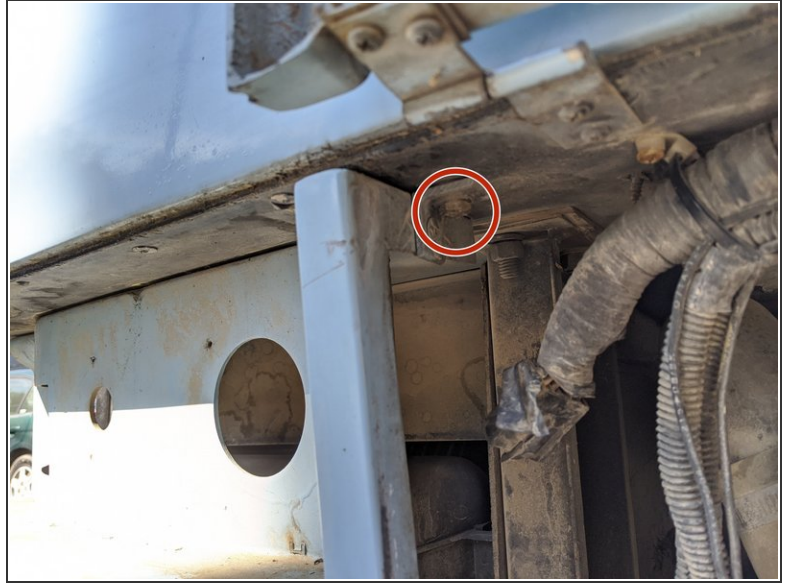
Step 3

- On my Vixen there was a hex head bolt on the top right, and a on-its-way-to-being-stripped Phillips head bolt on the top left.

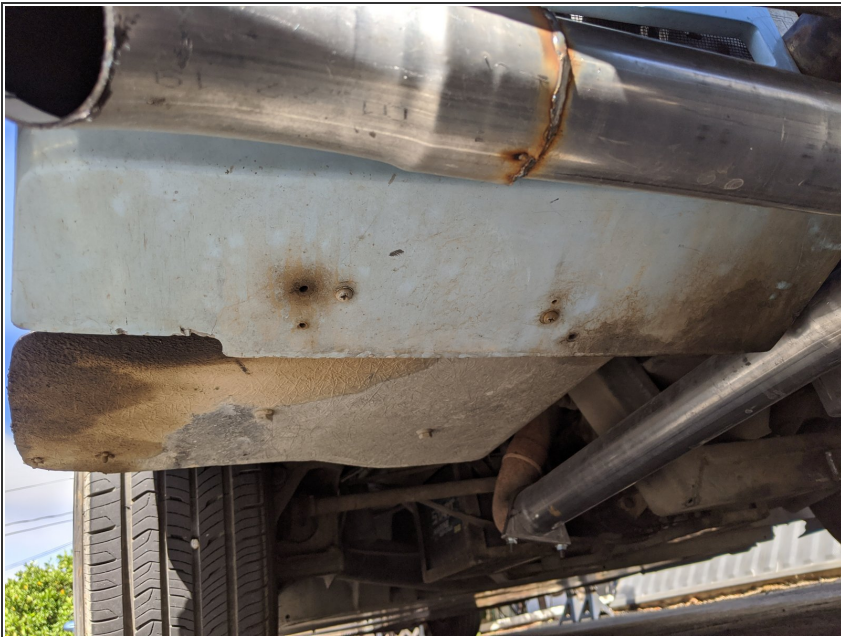
Step 4

- There were two Phillips screws in the bottom of the panel, but these weren't actually attached to anything.
- My new side-routed exhaust definitely made it harder to get this panel out.

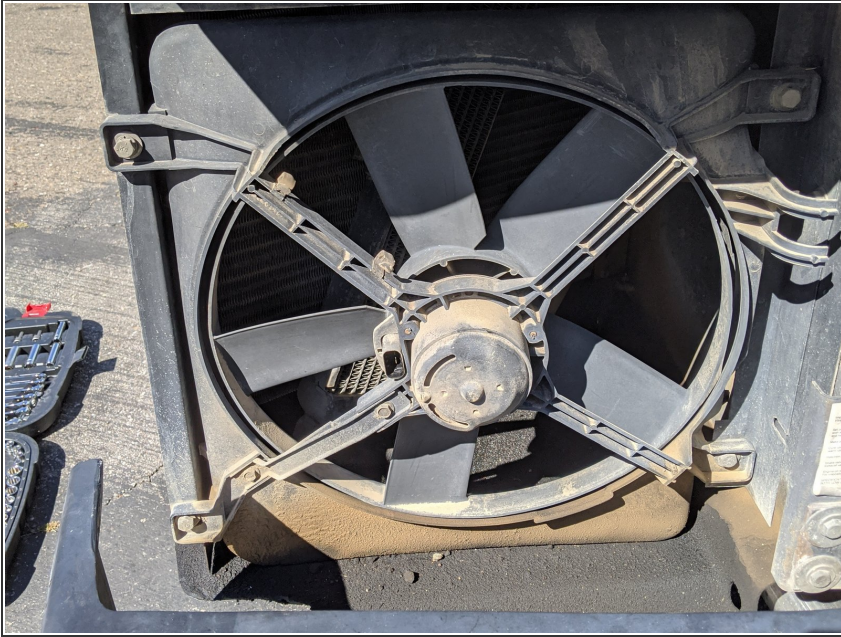
Step 5

- There's one electrical plug and 4 obvious hex bolts to remove the condenser fan.

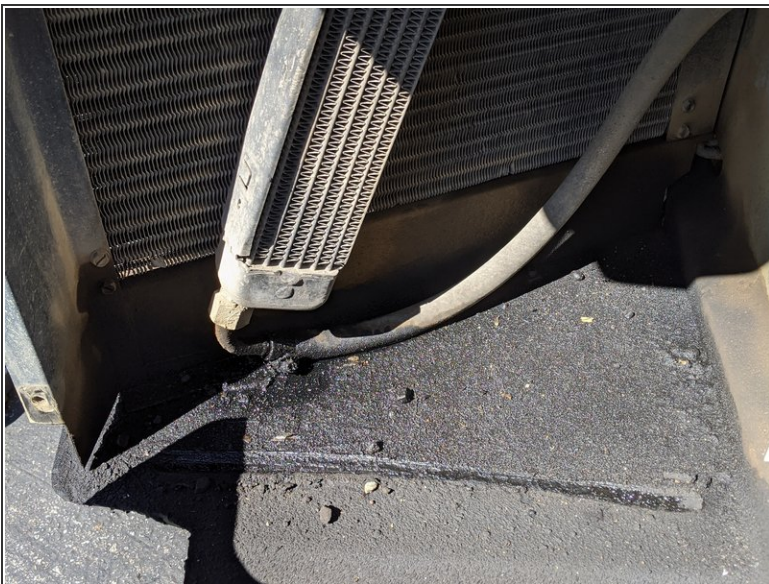
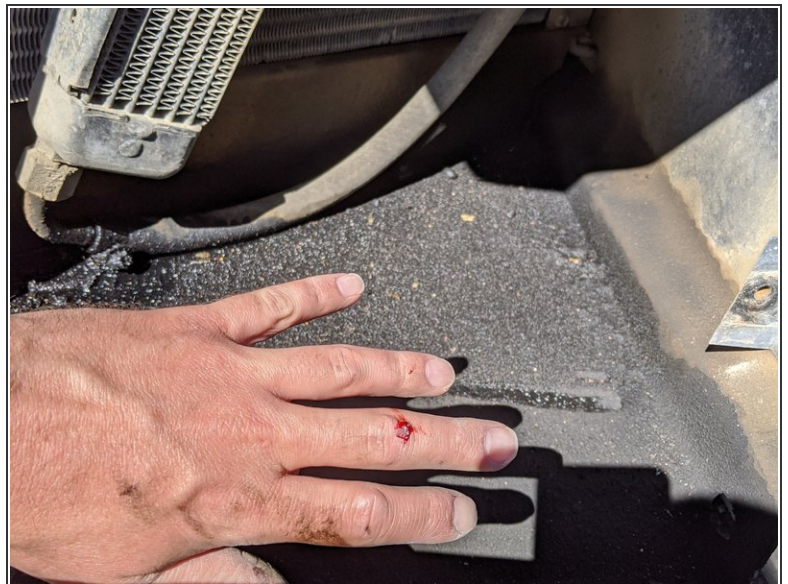
Step 6

- Once the condenser fan is removed we can get a good look at the oil cooler. The fittings are certainly leaking, but the cooler itself might actually be fine.
- The Vixen bleeds black and I bleed red, whoops!

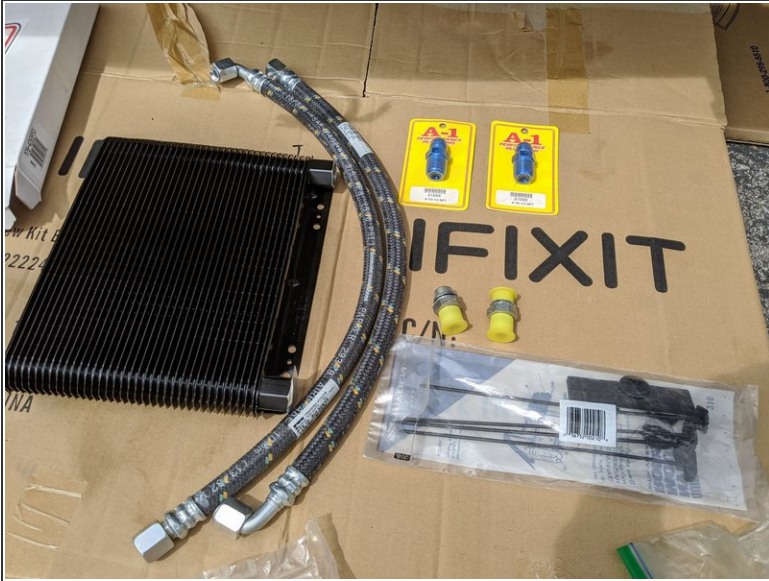
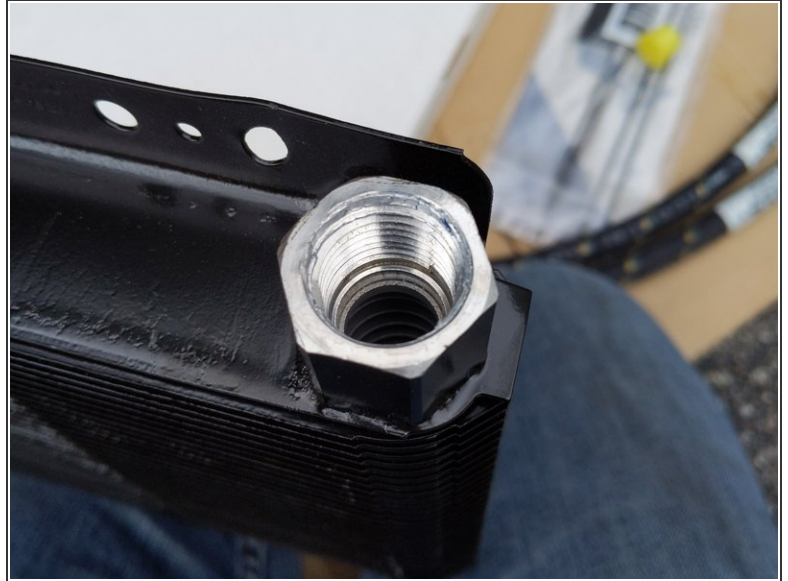
Step 7

- Here's all the shiny new replacement parts. You can buy the [oil cooler kit from AFAB](#).
- I made a mess of the threads putting one of the blue aluminum fittings in to the top of the new oil cooler. Thanks to a [1/2" NPT tap and die from Harbor Freight](#) and a friend's help I was able to salvage it and I don't think it leaks, but time will tell...

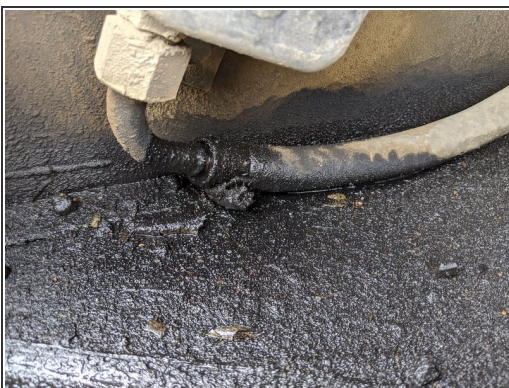
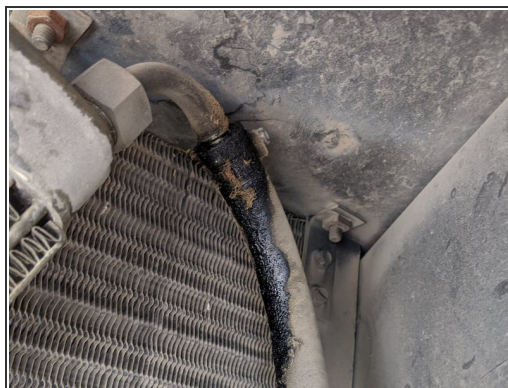
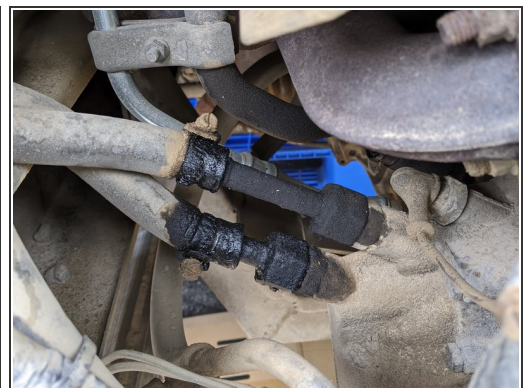
Step 8

- On a closer inspection, all my existing fittings are leaking, which at this point I suppose is a good sign.

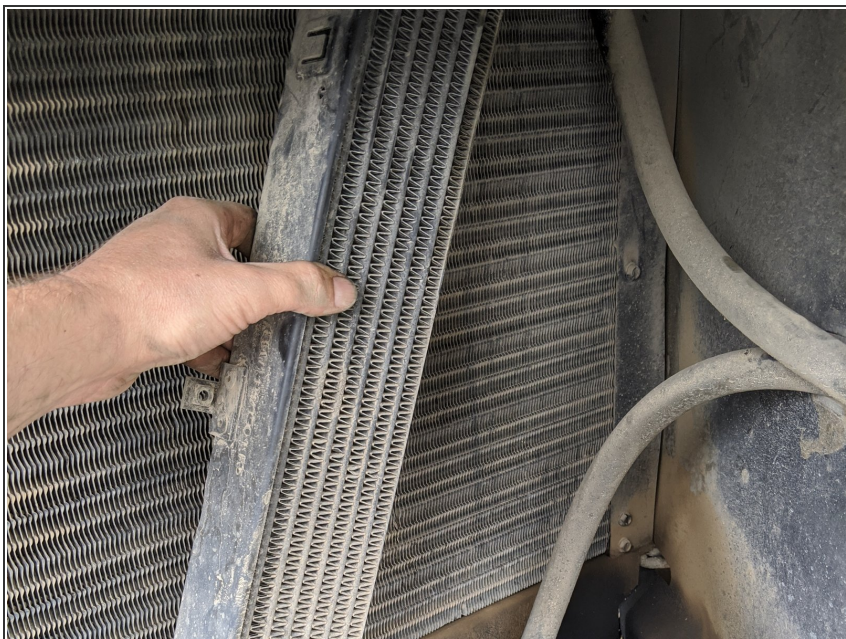
Step 9

- Getting the oil cooler off the condenser was easy, there's just two bolts. But it's still attached to the engine...

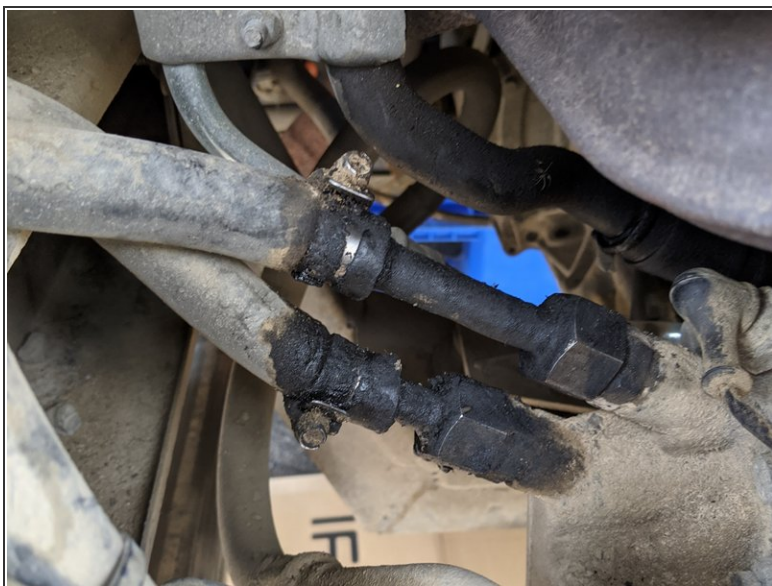
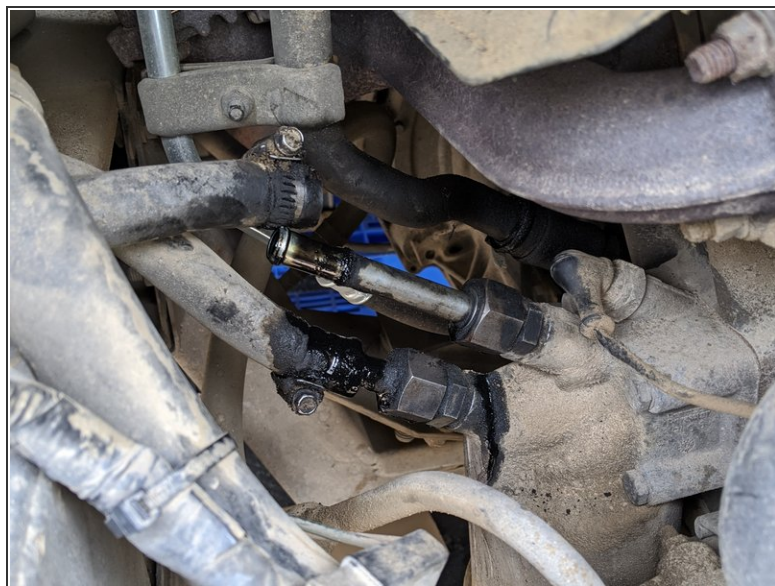
Step 10

- It was easy enough to loosen the hose clamps and pop the hoses off.
- This made a mess, because not surprisingly, there's oil in the lines.

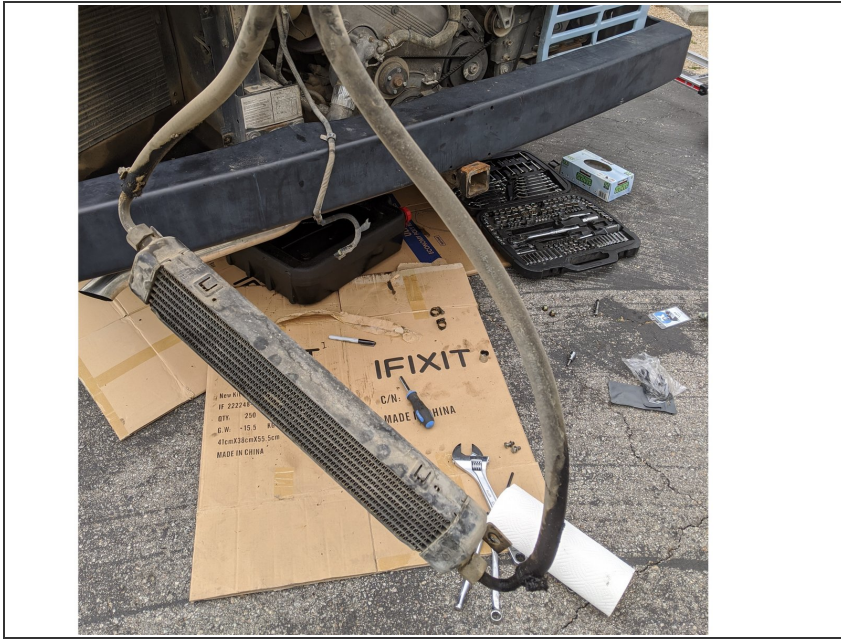
Step 11

- The old oil cooler is out!

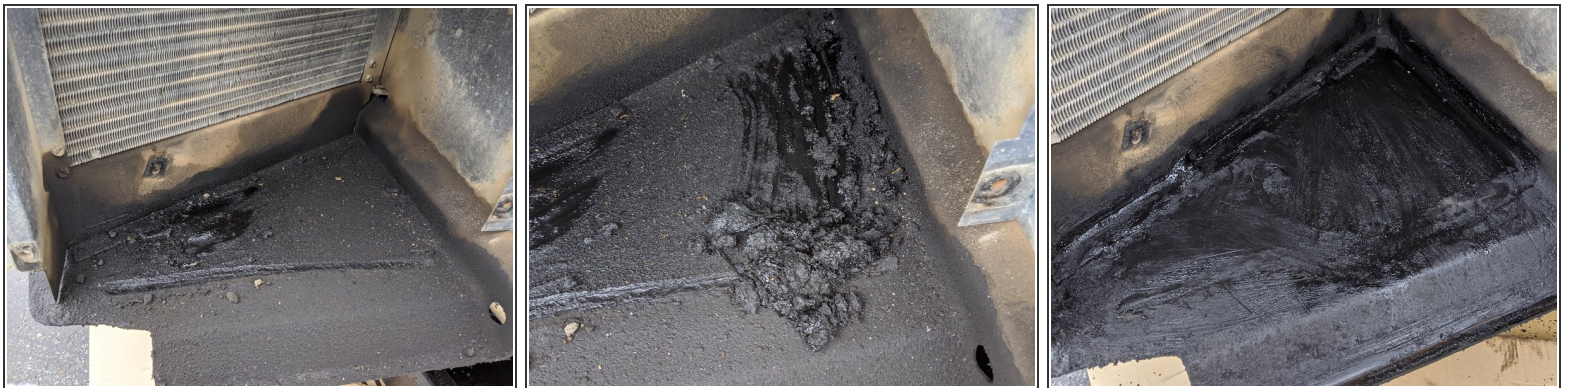
Step 12

- There was a lot of oil/dust sludge beneath the oil cooler, requiring a rather dirty cleanup.

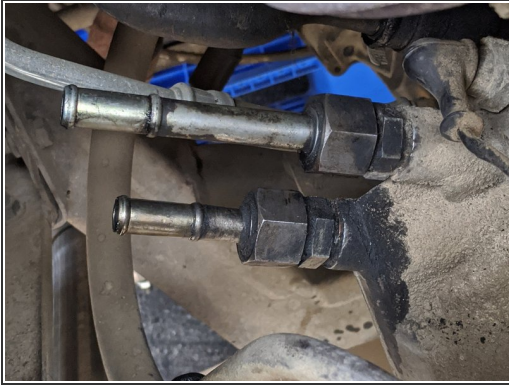
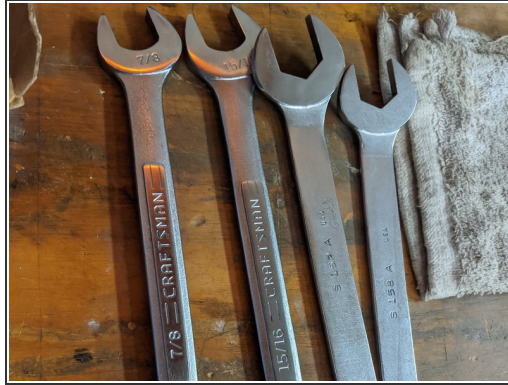
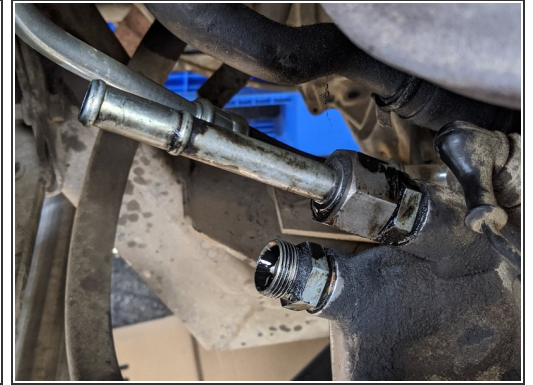
Step 13

- Removing the remaining couplers was quite challenging.
- I was able to borrow some large metric wrenches (24 mm and 27 mm) from a friend to help with this step.

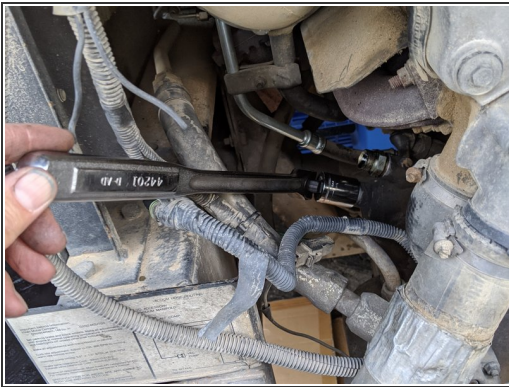
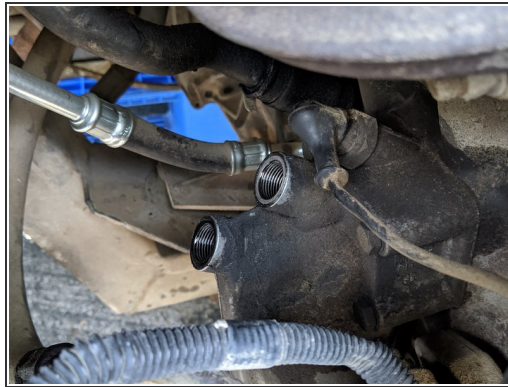
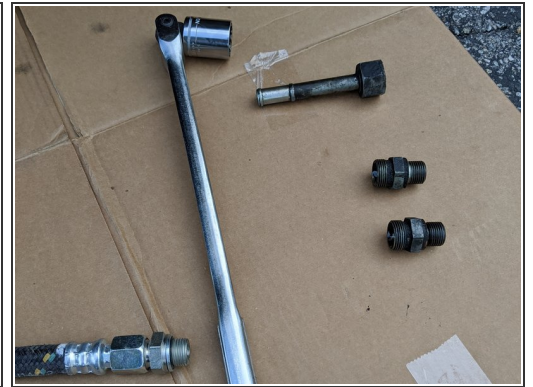
Step 14

- After the first fitting was off, I was able to get a 24 mm socket over the second one to remove the fitting.

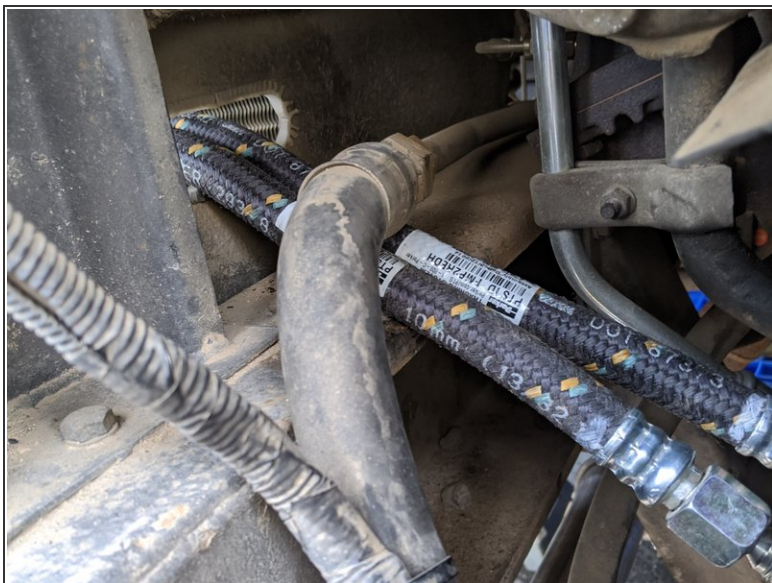
Step 15

- I routed the new lines the same as the old ones.
- The plastic lining the hole the hoses go through is definitely decaying, but seems like it'll still protect the hoses ok.

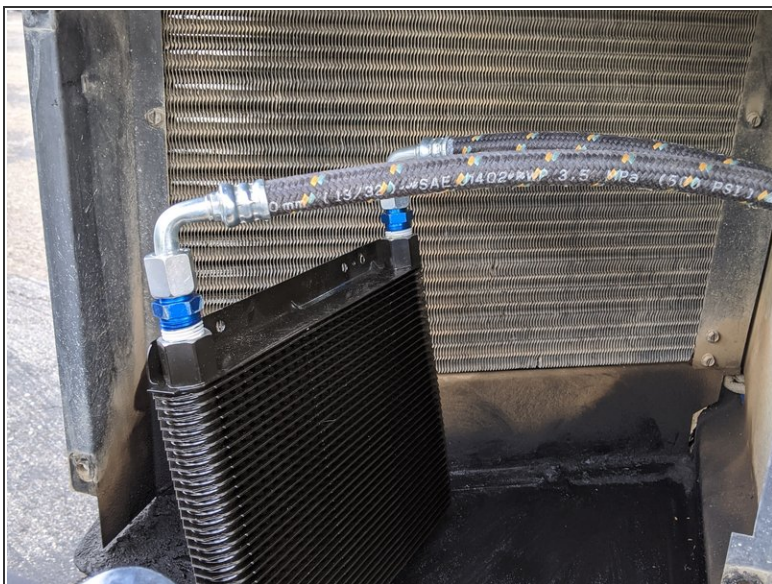
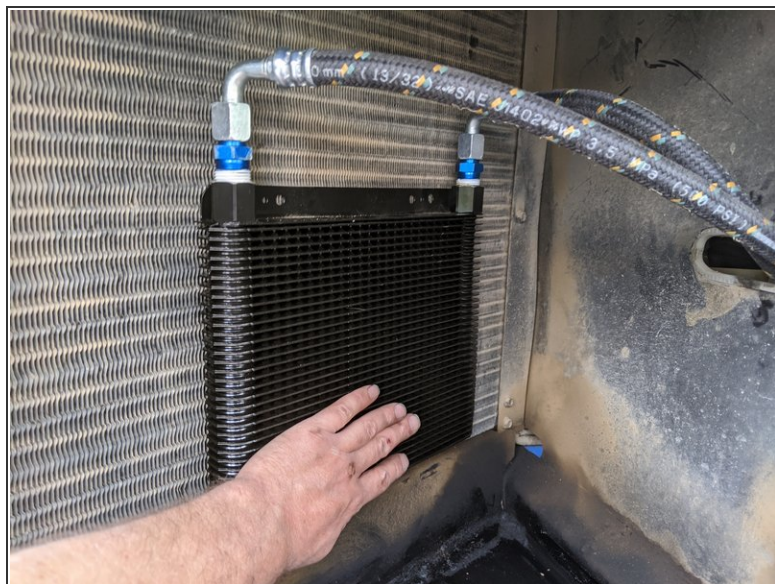
Step 16

- The lines are just barely long enough, but it reaches!

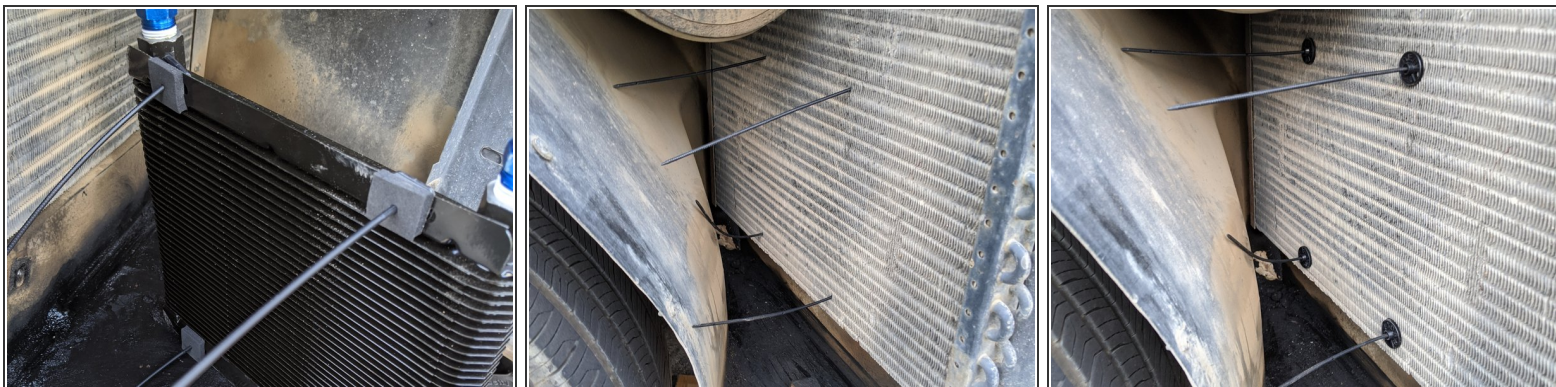
Step 17

- Mounting to the condenser is straightforward.
