Lenovo 100e Chromebook 2nd Gen Camera Replacement

This guide will show the steps needed to take...

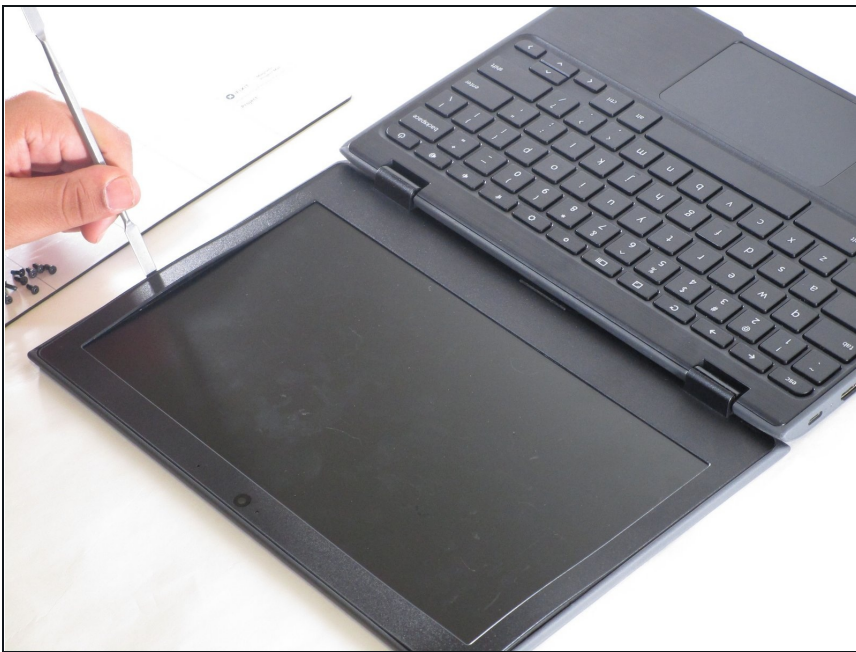
Step 1 — Screen Bezel

- Using a spudger, go along the edge of the screen and pop the connections between the cover and the back side out.

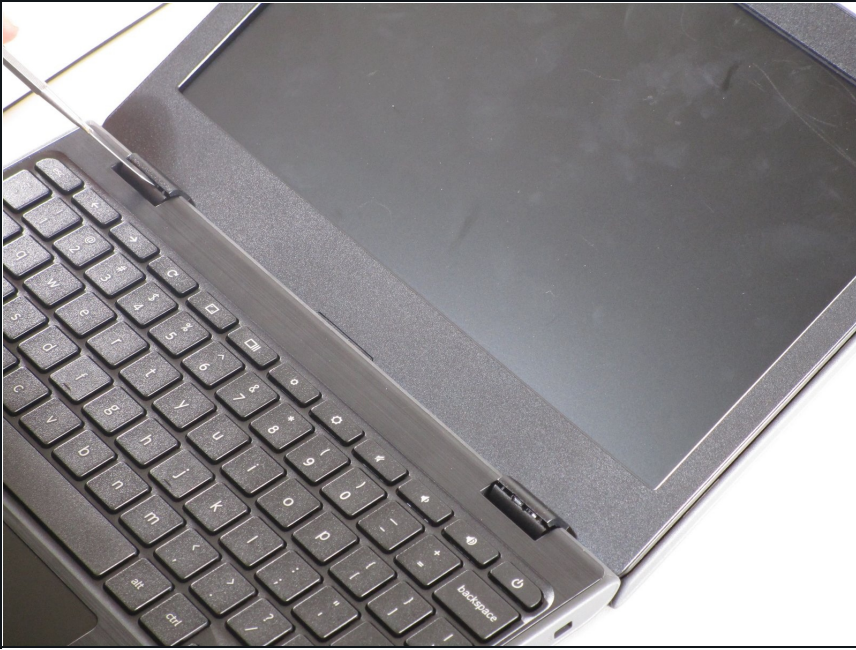
Step 2

- Insert the spudger into the gap between the hinges and pull up to detach the connections.

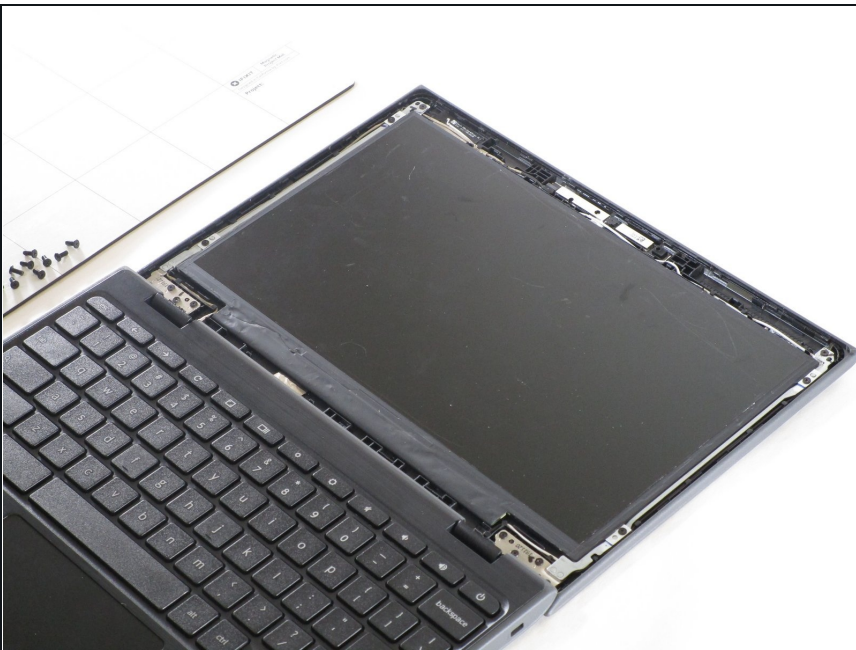
Step 3

- Remove the screen bezel from the laptop.
