# Vinotemp VT-12TEDi Motherboard Repair

Remove the motherboard (and connected heat sink) for repair or replacement.

Written By: Jeff Snyder

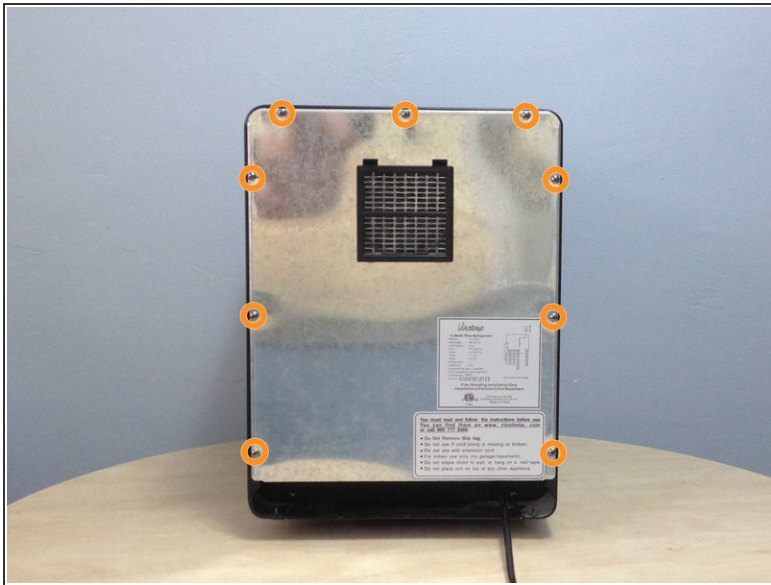
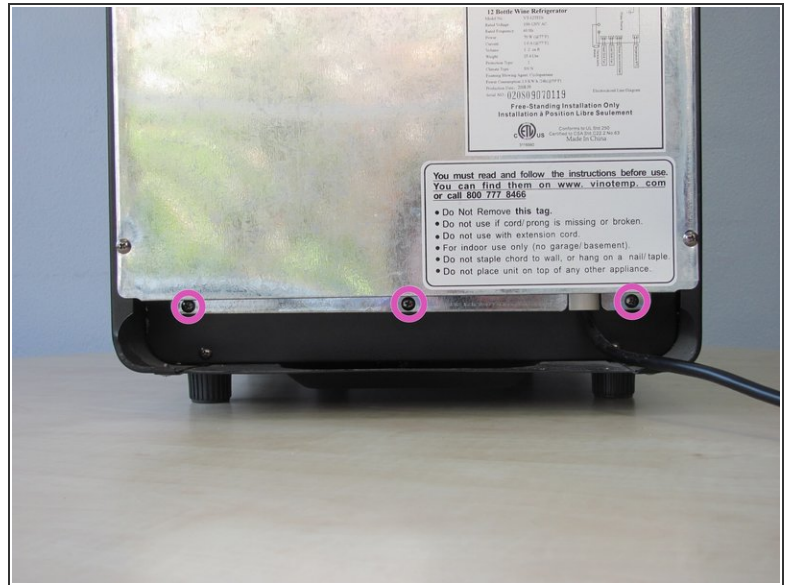
## Step 1 — Power Cord

- Remove nine 12mm Phillips screws from the upper back panel.
- Remove three 12mm Phillips screws inset under the back panel.

As soon as the screws are removed, the panel will fall freely.

When replacing the twelve 12mm Phillips screws, do not tighten the fasteners until all twelve screws have been loosely fitted back onto the cooler. This will ensure the flimsy metal casing will not warp.

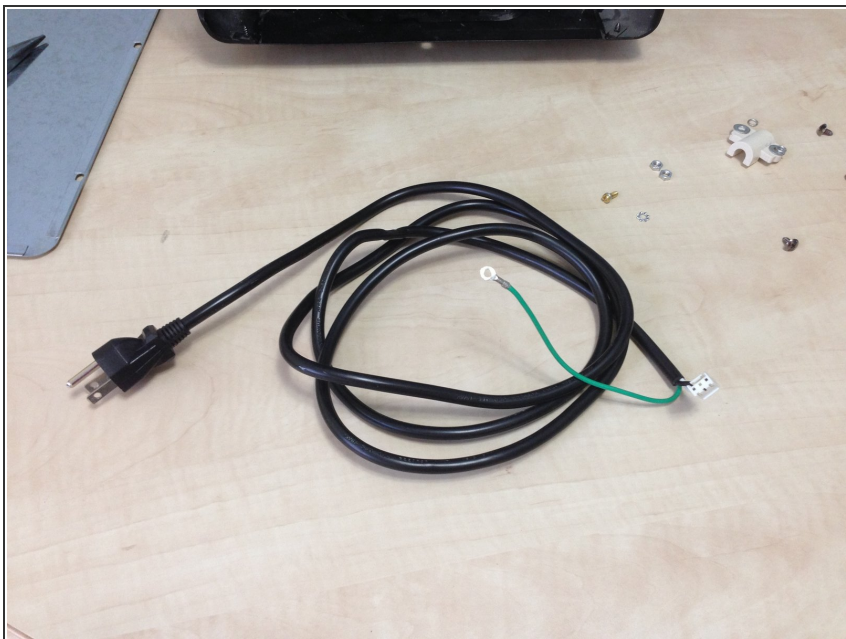
## Step 6

- Your power cord is removed.

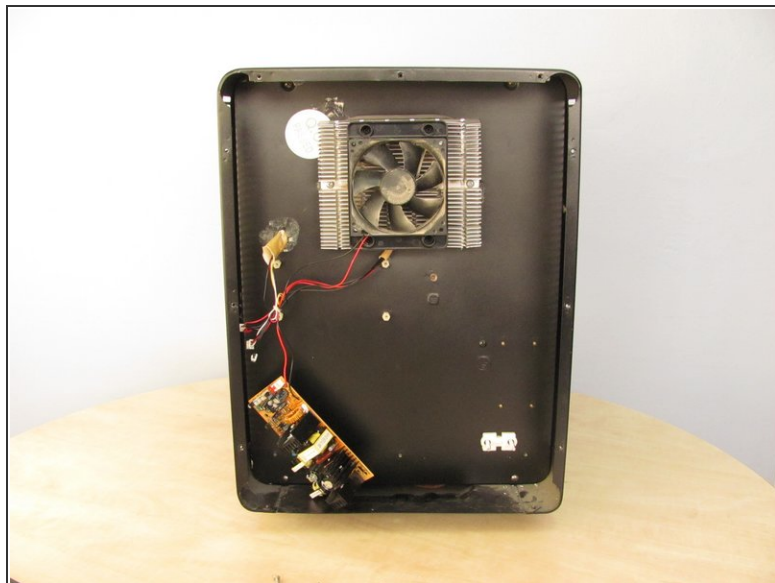
## Step 8

- Remove four 12mm Phillips screws.

⚠ Once the four Phillips screws are removed, the motherboard will dangle there until you remove the heat sink. Be careful.
