Beats Studio 2.0 Exploratory Teardown

Let the record show that at least one person on the internet tried to disassemble a pair of Beats Studio 2.0 headphones and post their initial results. Do NOT follow the steps in this guide. Read the text and learn from my mistakes.

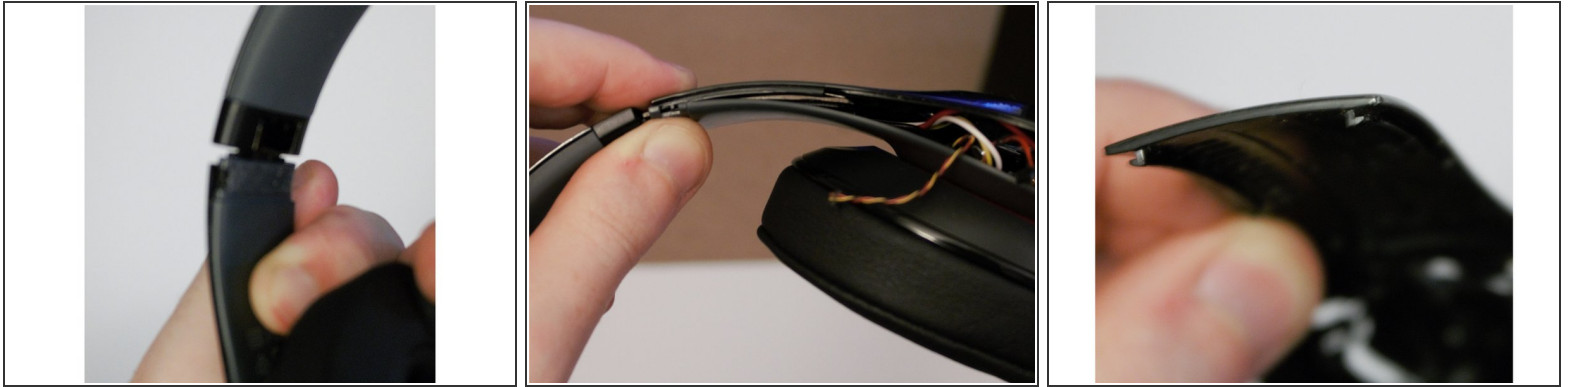
Step 3 — Method for separating outer plastic pieces

- By putting a thin spudger between the two halves of the plastic container, it is fairly easy to separate the two halves. But the top likely won't come apart without a fight. There are two primary pieces to keep in mind:

- The small clips that show "L" and "R" should probably be removed before the two pieces are separated. They are clipped into the outer shell and adhered with a similar adhesive to the outer rings that were previously removed. **The trick: spread one side outwards as you are prying the broad section away from the rest of the shell.**

- Now to the main issue: there are deep "tracks" that clip the two halves together. I haven't been able to use a technique to make this easier, as you cannot "slide" the two halves apart. Just like the L/R clips, concentrate on stretching the inner (grey) part as much as possible. Force will be necessary; leave a comment if a better way is found.

⚠ You may be able to separate these pieces once or twice, but they do bend slightly and eventually the rails will deform, making reassembly impossible without modification.

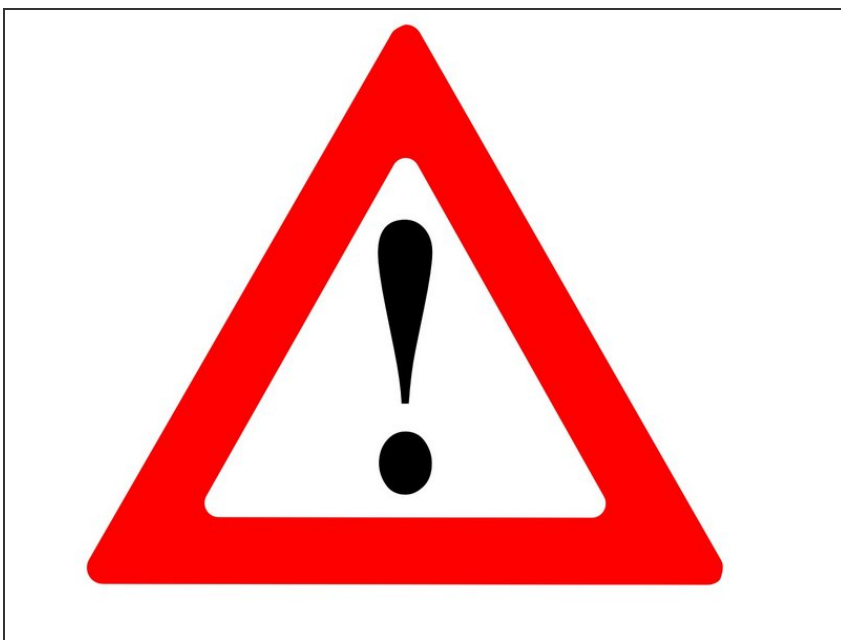
Step 5 — DO NOT ATTEMPT THE FOLLOWING STEPS

❗ **I completed the following steps in a way that causes irreversible damage** - its sole purpose is to give an idea of how one could go about to disassemble the set using a method and order that will not ruin the headphones.

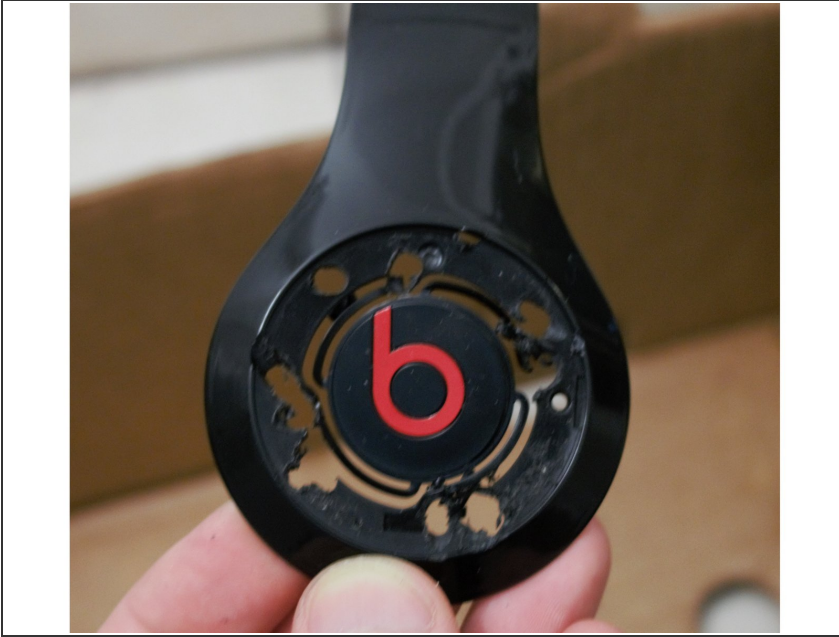
Step 6 — Asymmetry in screw placement

- Based on the previous side, I assumed that disassembly of the 3.5mm jack side (to be referred to as "jack side" from this point) would be similar. I started by removing the surrounding ring, only to find out that there was no screws hidden underneath.
- ⓘ From my memory, there is **absolutely no reason to remove this surrounding ring** on the jack side.
- After prying for a while, I began to wonder if some type of plastic clips were holding the two sides together. Knowing the two sides were already held together with strong "rails", I decided to drill out the areas where these clips were believed to be located

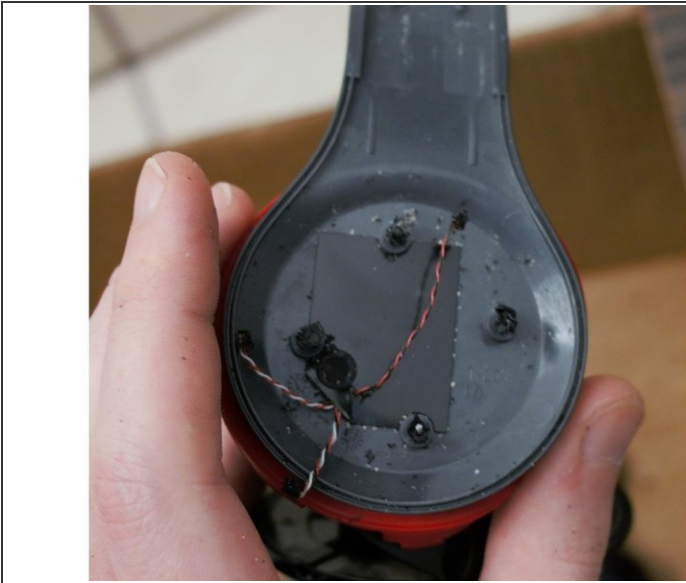
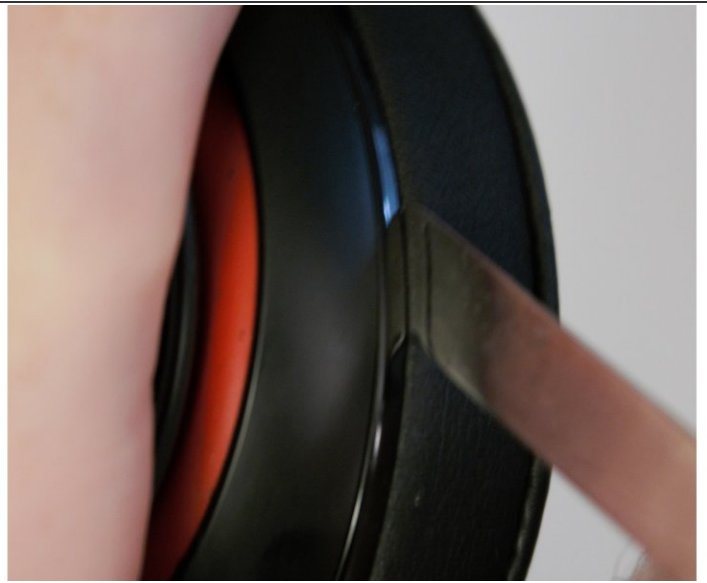
Step 8 — Proper jack-side disassembly: Foam surround

- The holes that were drilled revealed that screws were attached from the inner side of the earcup.
- There are a few seams to choose, but the one I chose (which is also the correct one) to begin further disassembly is between the **foam pad and the small first layer of plastic**.
- There is no magic that can help this step very much, as heat around the cushion can easily deform or melt the plastic, and heat from the back cannot penetrate the insulating plastic and air from the other side.
- Insert a metal or plastic spudger roughly half an inch between and slowly rotate to separate. You should hear the strong adhesive releasing slowly.
