Philips Satinelle Motor Replacement

This guide will help you replace the motor inside the Philips Satinelle. If the motor is not working, then the device will not turn on.

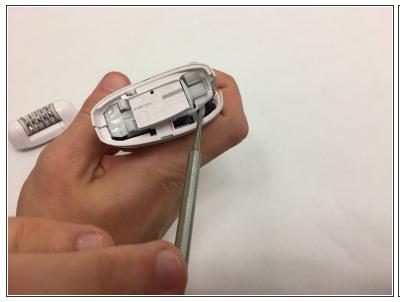
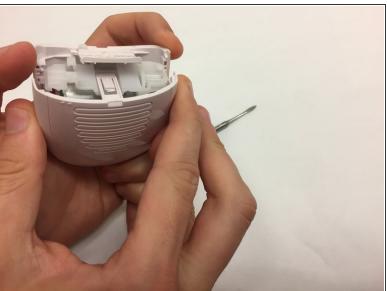
Step 2

• Use a metal spudger to pry open the casing.

↑ Caution: The epilator's internal components could be damaged if you shove the spudger in too far.

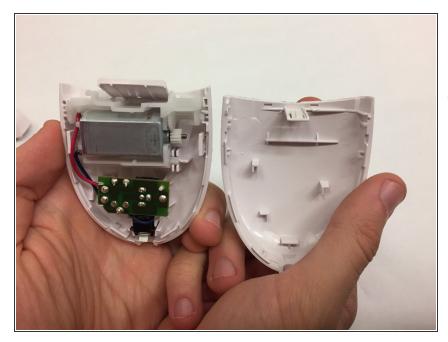
Step 3

- Pull the plastic casing apart with your hands.
- is likely going to break when you pull the device apart. This will not affect the operation of the epilator.

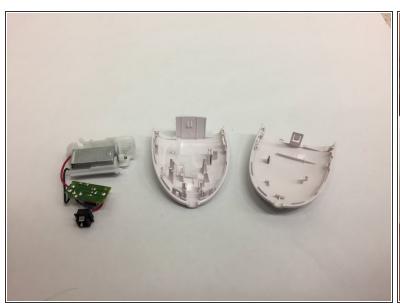
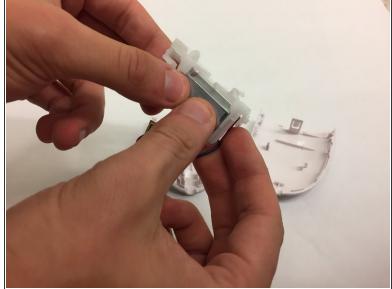
Step 4 — Motor

Remove the components.
