Lenovo Flex 6-11IGM Auxiliary and USB Port Replacement

This guide will help you replace the auxiliary and USB ports in your Lenovo Flex 6-11IGM (model #: 81A70005US).

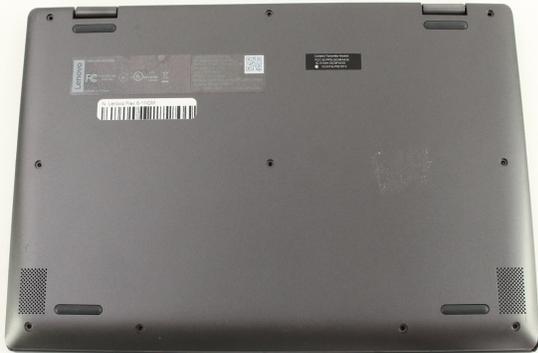
Step 1 — Back Panel

- Flip the device over and lay it down with the underside facing upwards.

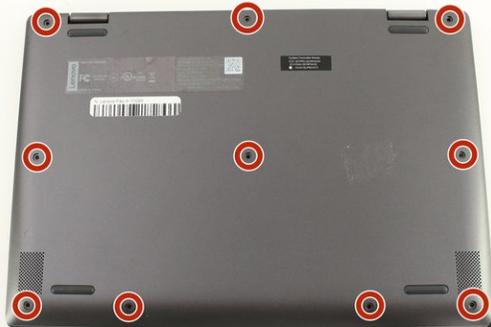
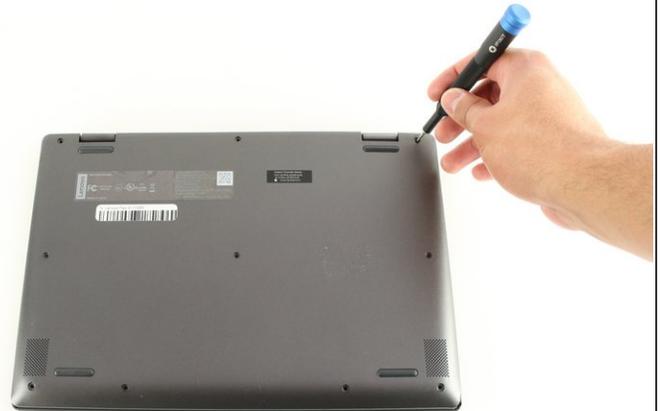
Step 2

- Remove the ten screws with a Phillips #00 screwdriver.

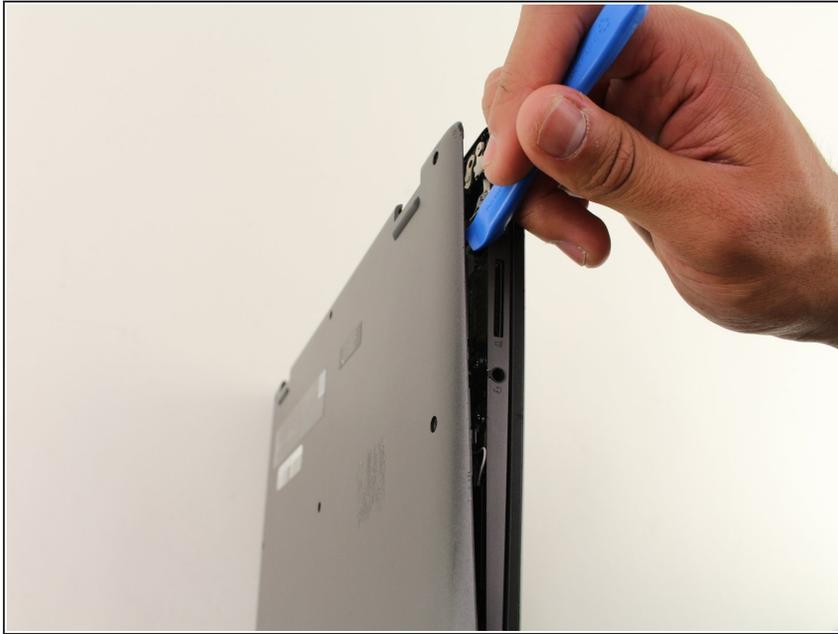
Step 3

- Using a plastic opening tool, make your way around the edge of the laptop.

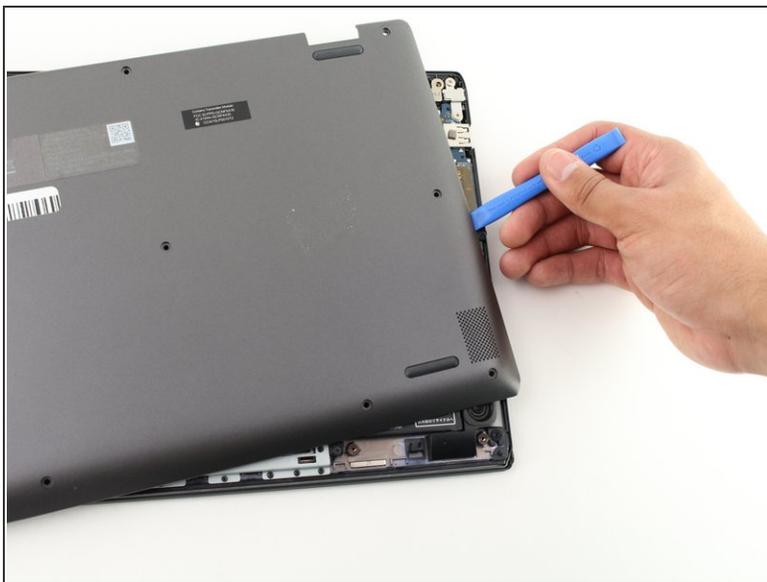
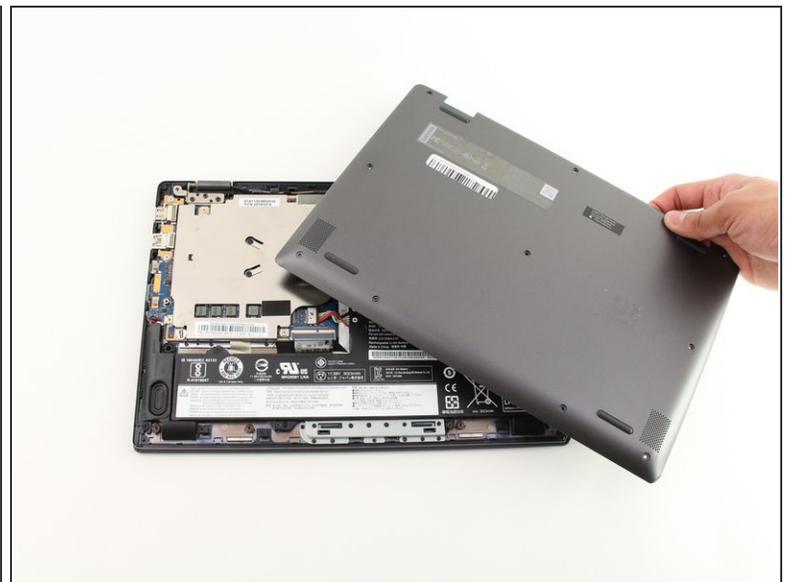
Step 4

- After making sure the back panel is completely free from the body, remove the back panel.

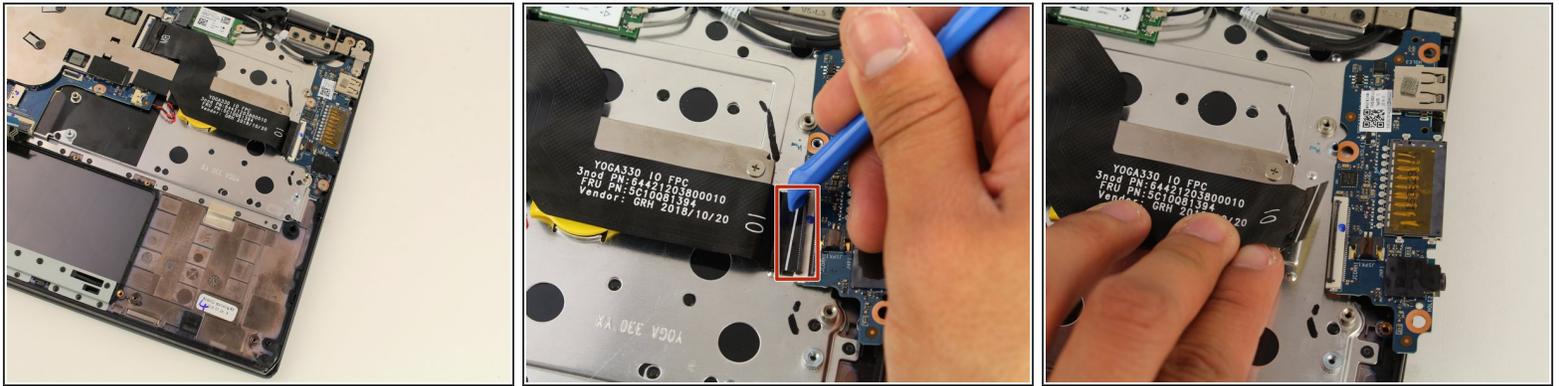
Step 5 — Auxiliary and USB Port

- Disconnect the ribbon connector using the iFixit opening tool tool by flipping up the black flap and pulling the ribbon out.

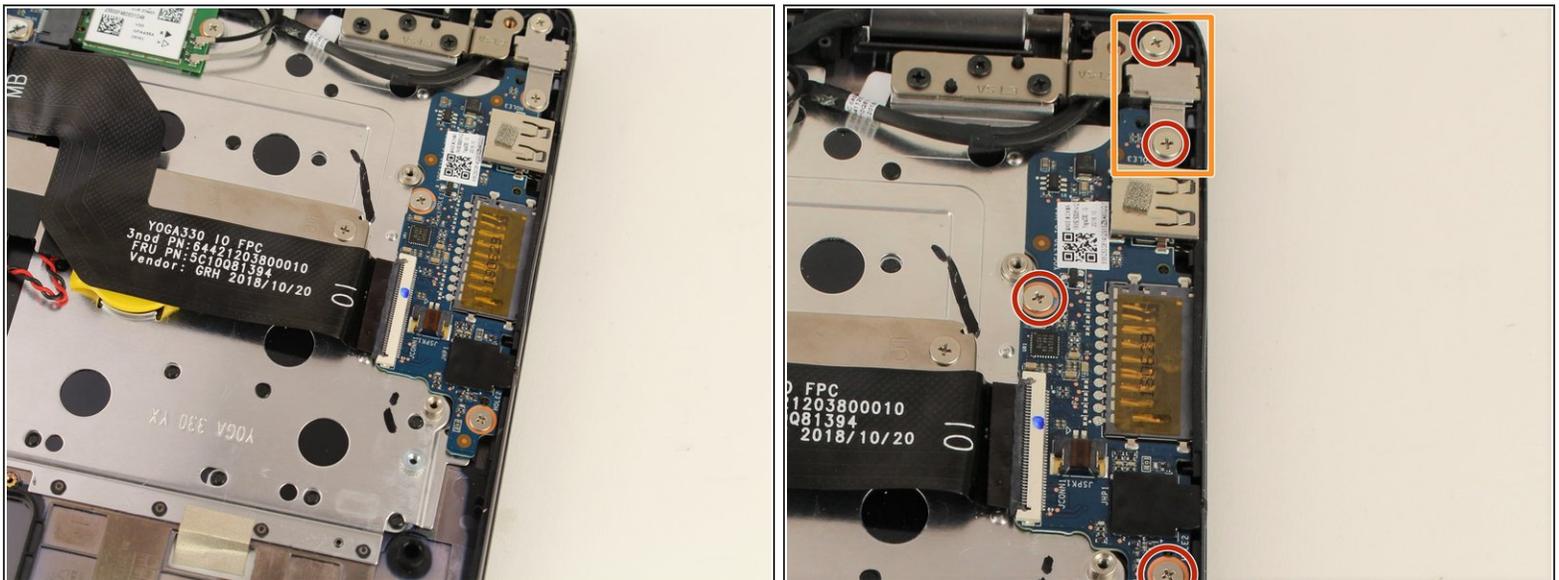
Step 6

- Take the three 3.5mm silver screws out using the Phillips #00 screwdriver.
- Remove the protective silver shield before removing the ports.
- Using the iFixit opening tool, insert its end underneath the ports, and pull them upwards toward you to remove them safely.

To reassemble your device, follow these instructions in reverse order.
