Lenovo 100e Chromebook 2nd Gen Headphone Jack Replacement

This guide will show the steps needed to take out and replace the headphone jack in the Lenovo Chromebook 100e 2nd gen. You will need a Phillips head screwdriver and a plastic pick for this guide.

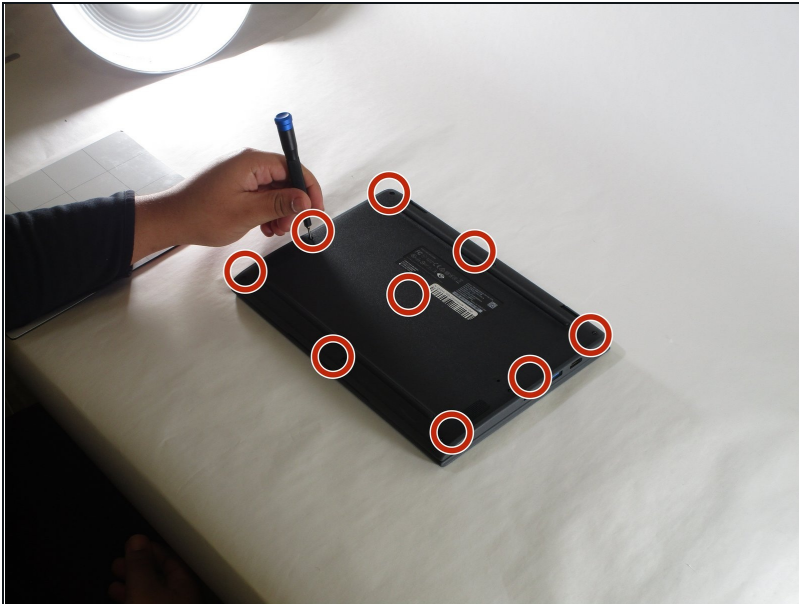
Step 1 — Keyboard

- Remove the nine 6 mm screws from the back of the laptop using a Phillips #0 screwdriver.

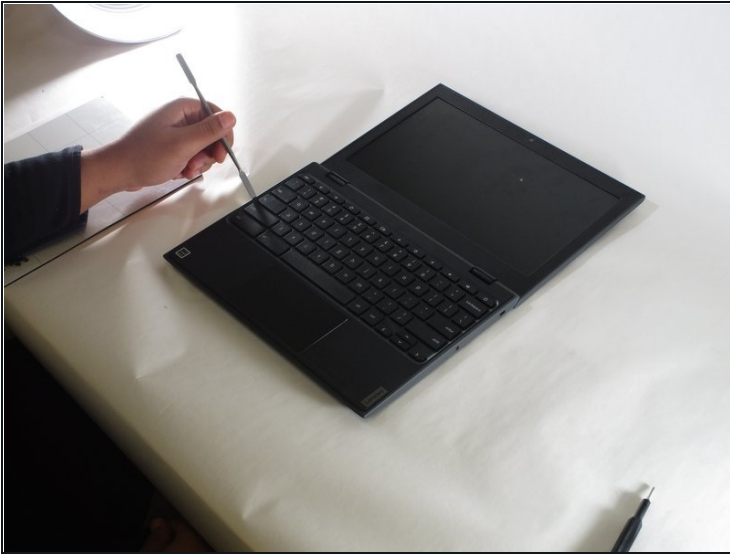
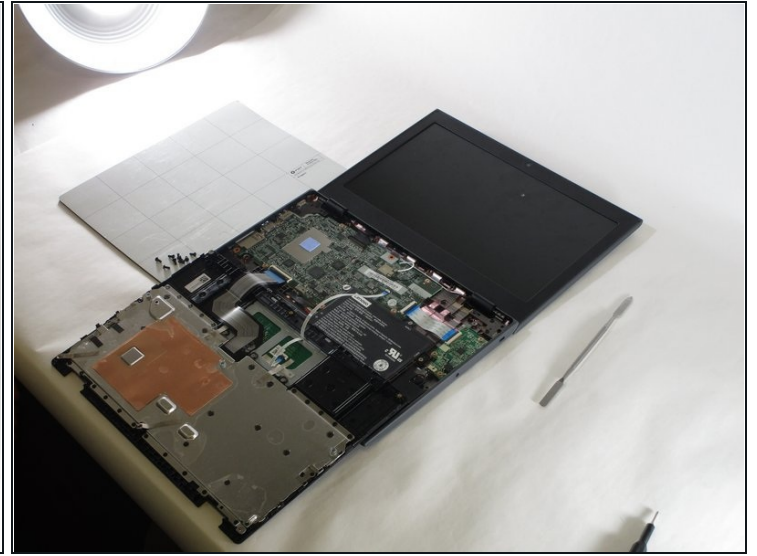
Step 2

- Open the laptop and lay it flat.
- Go along the edge of the keyboard with an opening tool until it pops loose.

⚠ Potential for device damage: Make sure that the keyboard does not fall away from the laptop, as it is still connected to the internal components

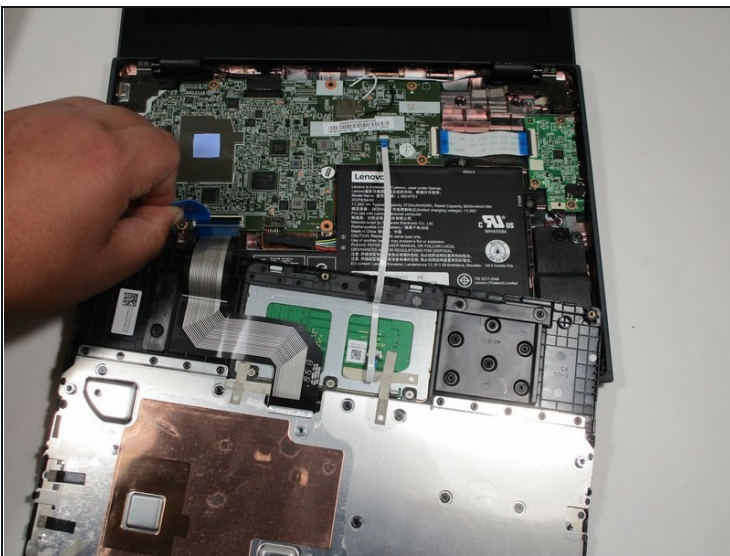
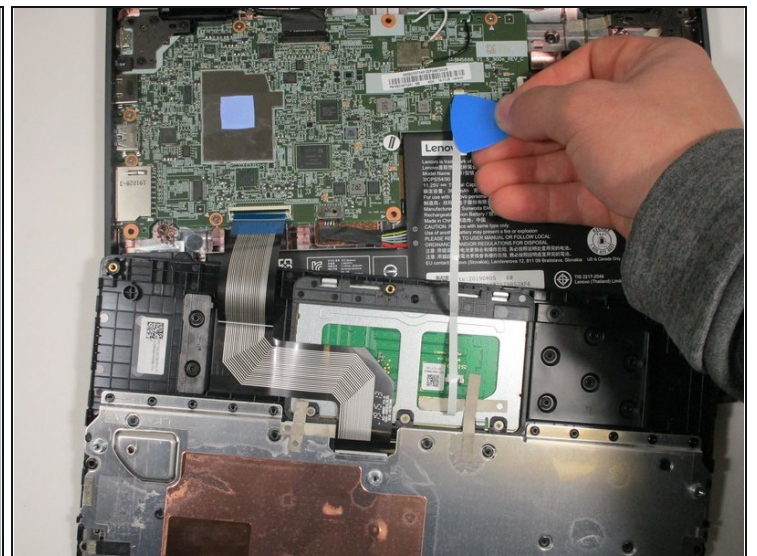
Step 3

- Lift the keyboard connectors up using an opening pick.
- Remove the connectors from their sockets.

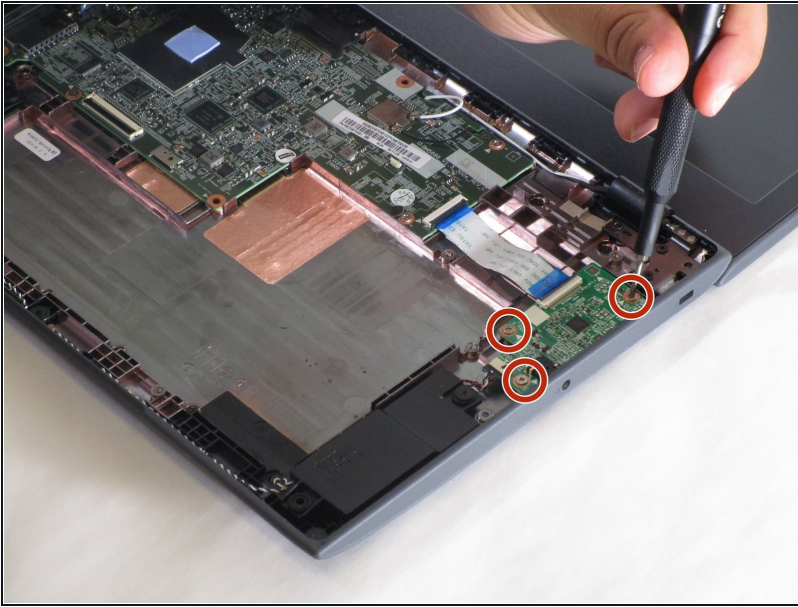
Step 4 — Headphone Jack

- Remove the three 4 mm Phillips #0 screws holding the headphone jack in place.

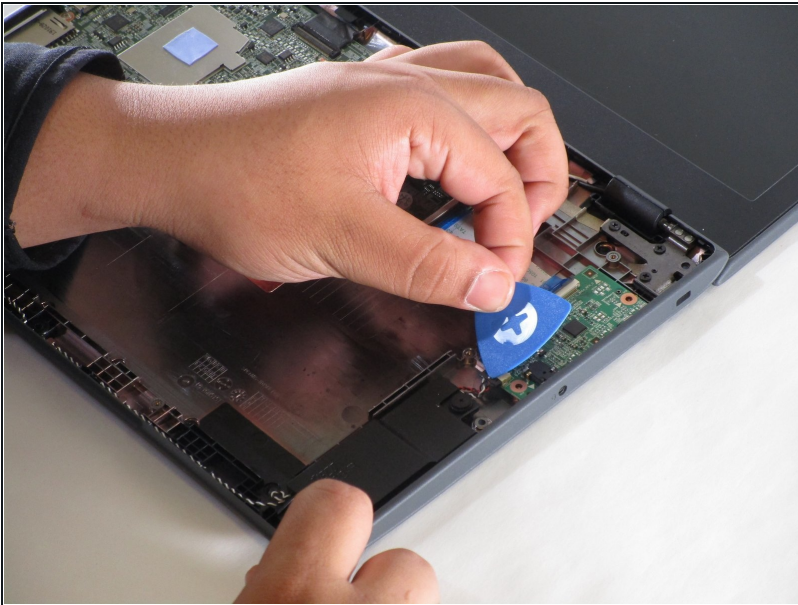
Step 5

- Using a plastic opening pick, remove the connection between the aux port and the speakers.

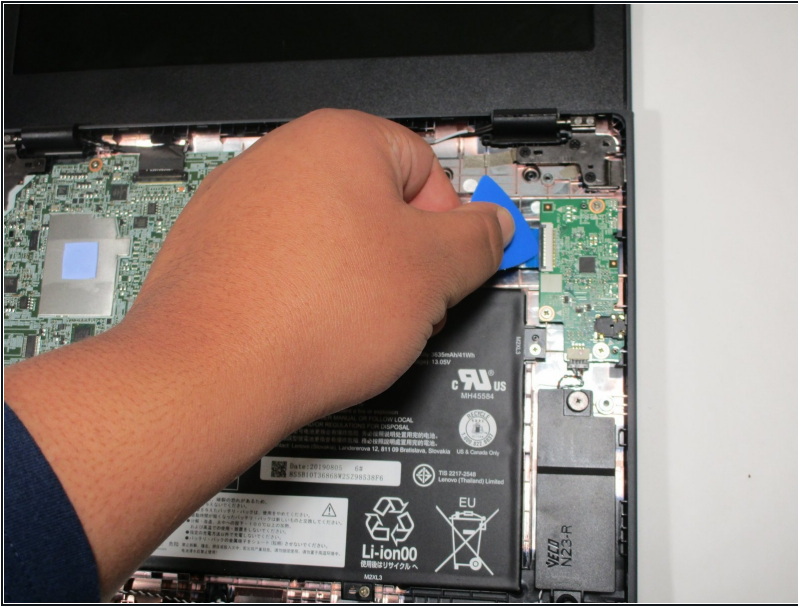
Step 6

- Using the plastic opening pick, pop the retaining flap holding the ribbon cable in place.
- Remove the headphone jack from the laptop.

To reassemble your device, follow these instructions in reverse order.
