Lenovo 100e Chromebook 2nd Gen Screen Bezel Replacement

Written By: Pup Washington

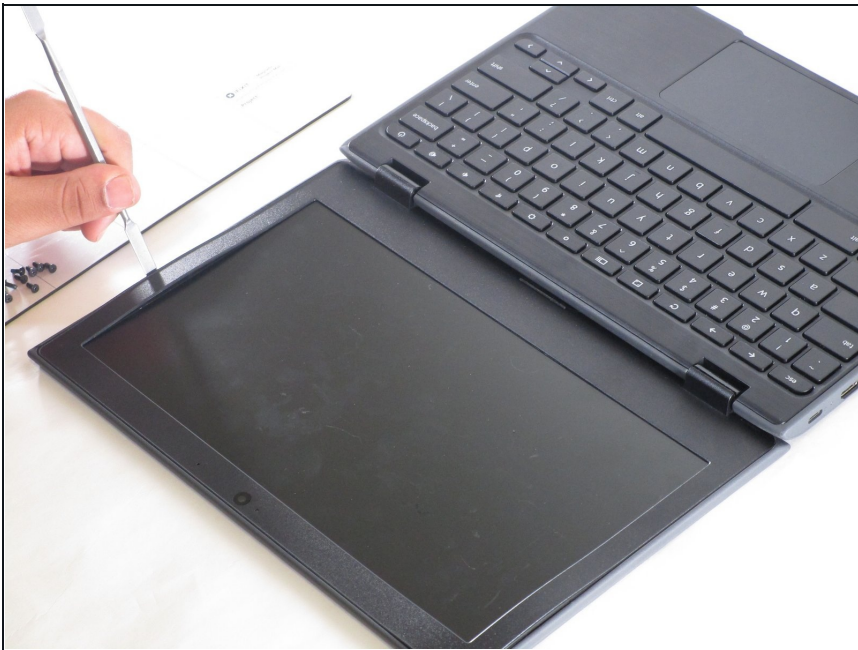
Step 1 — Screen Bezel

- Using a spudger, go along the edge of the screen and pop the connections between the cover and the back side out.

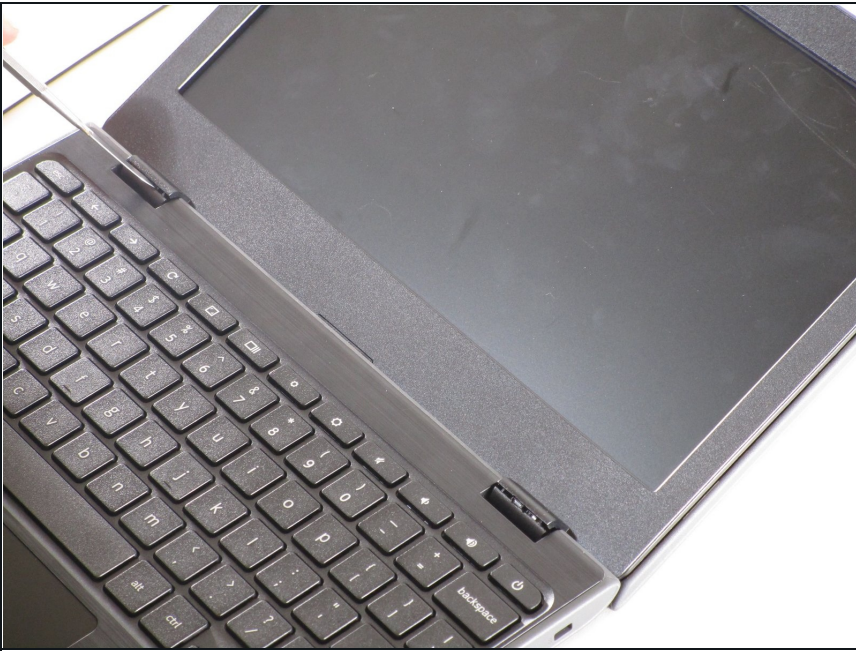
Step 2

- Insert the spudger into the gap between the hinges and pull up to detach the connections.

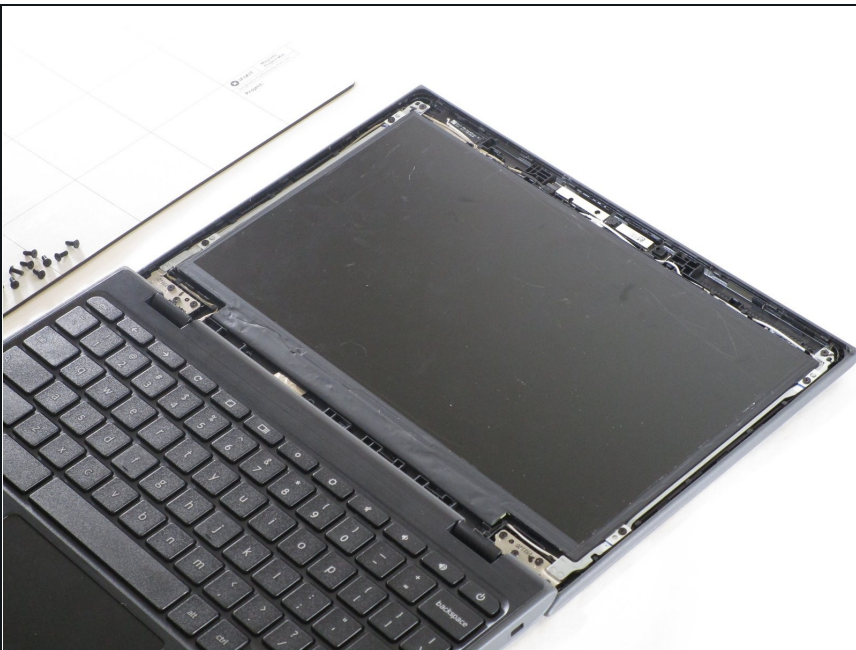
Step 3

- Remove the screen bezel from the laptop.

To reassemble your device, follow these instructions in reverse order.
