# How to fix squeaking on the GEN 2 Wheelchair

This guide will show how to fix squeaking parts on the Free Wheelchair Mission GEN 2 wheelchair

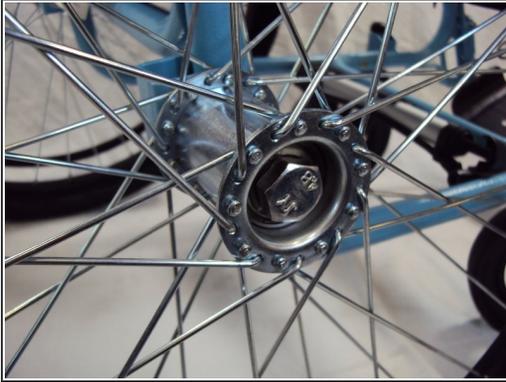
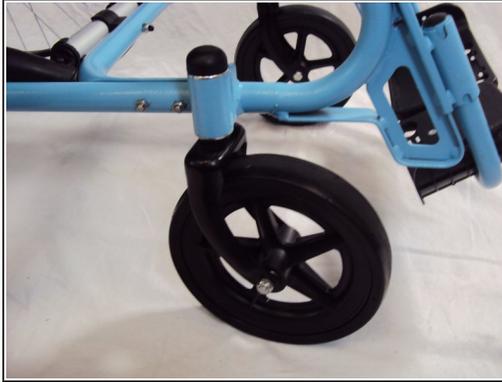
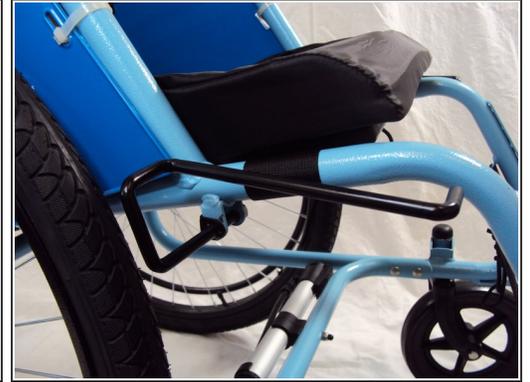
## Step 1 — How to fix squeaking on the GEN 2 Wheelchair

- Locate the source of the squeaking.
- ⓘ Typically, this will be one of the rear wheels, castor wheels, or brakes.
- Clean and remove any dirt or rust from the source of the squeaking.
- ⓘ You may need to partially disassemble the squeaking part in order to thoroughly clean it.

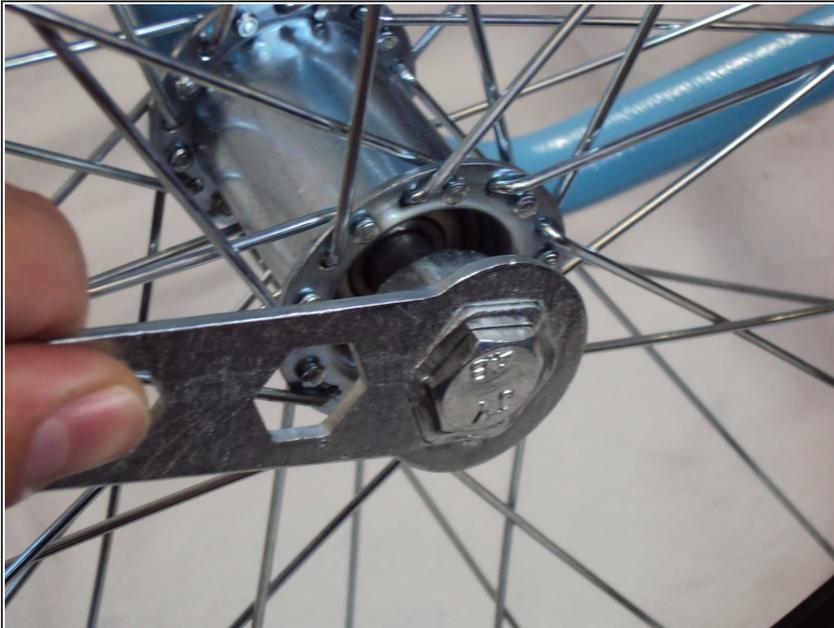
## Step 2

- Check for improper assembly.
- ⓘ Refer to the teardown to check that the wheelchair is properly assembled.
- Check for proper lubrication. If not lubricated, lubricate thoroughly with bike grease.

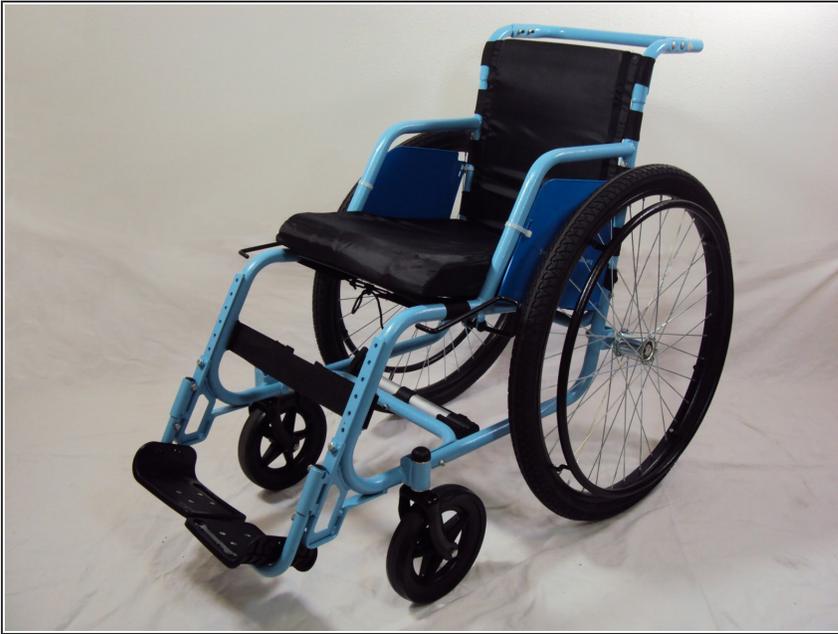
### Step 3

- Check to see if the squeaking has stopped by rolling the wheelchair around.
- ⓘ If the squeaking continues, recheck the chair thoroughly to locate the problem. Once located, repeat the steps until squeaking has stopped.

Squeaking can be caused by overly tightened connections. If problem still occurs after going through steps, try to slightly loosen bolts (half a turn of the wrench) near the source of squeaking.
