# HTC One (M8) Teardown

Teardown of the HTC One (M8) on March 25, 2014.

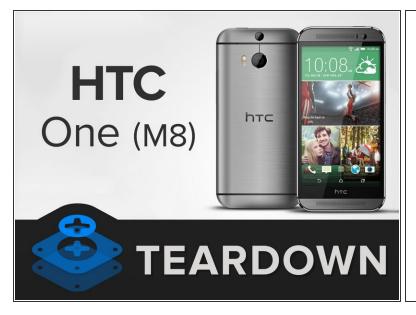
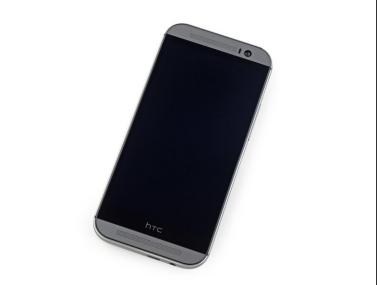
- For its second act, the HTC One brings some impressive props. The lengthy list of hardware includes:
  - Quad-core, 2.3 GHz Qualcomm Snapdragon 801 processor
  - 2 GB RAM
  - 5" 1080p display with dual front-facing speakers
  - 4 MP (2 "ultrapixel") f/2.0 rear Duo Camera with dual flash; 5.0 megapixel front-facing camera
  - 16 or 32 GB on-board storage; up to 128 GB additional storage via microSD
  - LTE, Bluetooth 3.0, NFC, 802.11ac Wi-Fi, and IR blaster
- The immediate question is whether the M8 will prove more cooperative than its <u>nigh-unrepairable</u> <u>predecessor</u>, whose hardware secrets had to be pried from its mangled aluminum corpse.

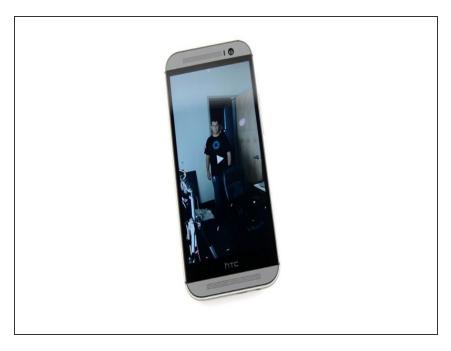
- The extra rear camera captures depth information, enabling a host of trick features like ex post facto focus adjustments and background removal. We can hardly wait to dig our spudgers in and see how it comes apart.
  - But first: an homage to Mirosenpai.

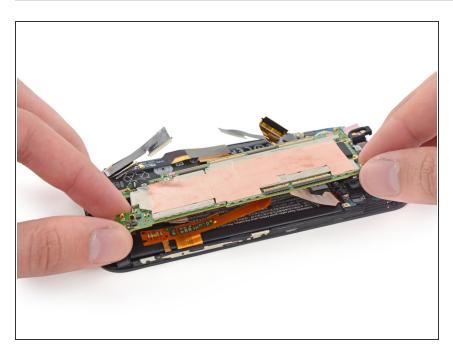
- If the rear case removal sparked our hopes for an improved repairability score, this glued-down motherboard is a <u>bad sign</u>.
- To improve is to change; to perfect is to change often. From a repairability standpoint, we'd like to see more change from this One.

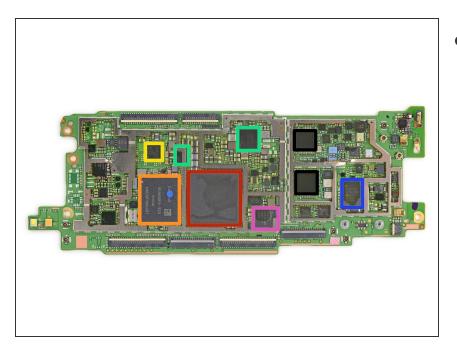
- The shields are down! Here's what we found lurking below:
  - Elpida FA164A2PM 2 GB RAM + Qualcomm Snapdragon 801 quad-core 2.3 GHz CPU
  - SanDisk SDIN8DE4 32 GB
     NAND flash memory
  - STMicroelectronics 0100 AA 9058401 MYS
  - Qualcomm <u>PM8941</u> and <u>PM8841</u> power management ICs
  - Avago <u>ACPM-7600</u> power amplifier module
  - Synaptics S3528A touchscreen controller
  - Qualcomm <u>WTR1625L</u> RF transceiver and WTR1625 (modem?)

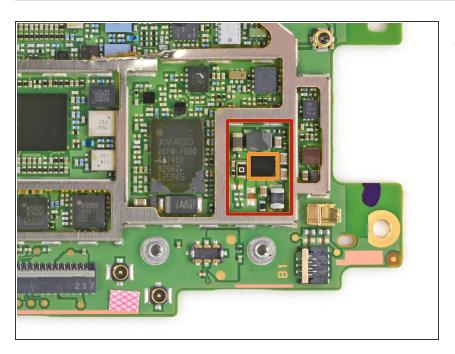
- A close up of the RF front end, highlighting the Qualcomm ET subsystem. That's "Envelope Tracking", not "ExtraTerrestrial".
  - Inside the red line is the Qualcomm QFE1100 ET IC, plus all the associated passives, weighing in at around 50mm2 for the whole footprint.
  - The QFE1100 ETIC itself

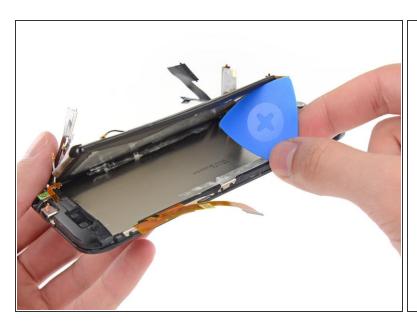
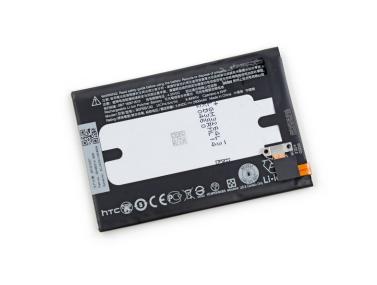
- With the motherboard free, we turn our attention to the battery.
- You heard right: you have to remove the motherboard to get to the battery, <u>again</u>, which is more than lightly adhered to the LCD shield.
  - i This super-sized serving of adhesive is sure to be a health risk for the M8's repairability score. Too bad HTC doesn't take a recipe from Google's book.
- HTC touted the all-new One's exceptional battery management, with up to 2 weeks of standby from a 100% charge, and 15 hours on 5%. Wowsers.
  - (i) Much of this comes from low-power sensors and clever software, plus a 2600 mAh battery, up 300 mAh from last year.

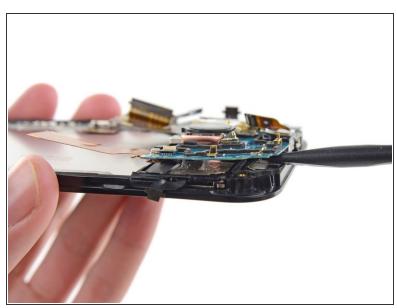
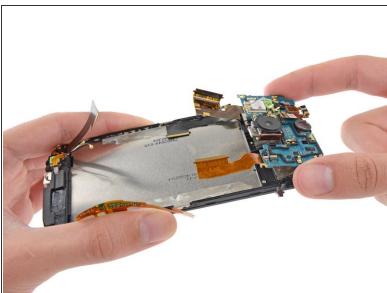
- Or at least we thought we were, until we found the glue holding the board in place.
  - Our will spudger is strong, but our spudgering arm is getting mighty tired.
- With the daughterboard free, it's time to gather 'round for a peek at the fancy camera tech.

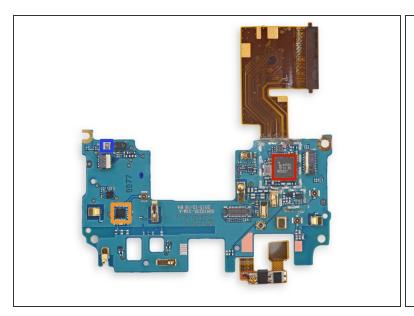
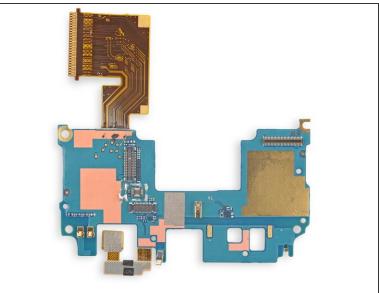
- Keeping each other company on the now-sparsely-populated daughterboard are a couple of remaining chips:
  - NXP <u>44701</u> NFC controller
  - Bosch Sensortec BMP280 pressure sensor
  - Qualcomm <u>QFE1550</u> dynamic antenna matching tuner

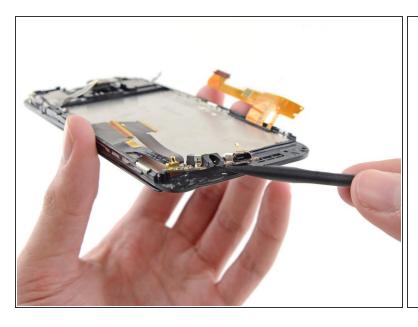
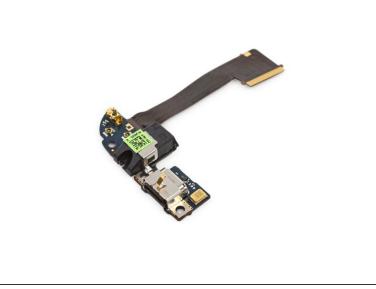
- Last to leave the party is the 3.5 mm audio jack, now sharing a small cable assembly with the microphone and micro-USB port on the bottom of the phone.
- We give it a gentle nudge out the door with the spudger. The end is in sight...

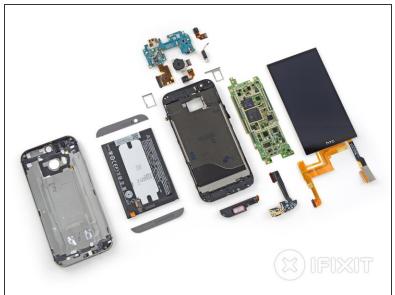
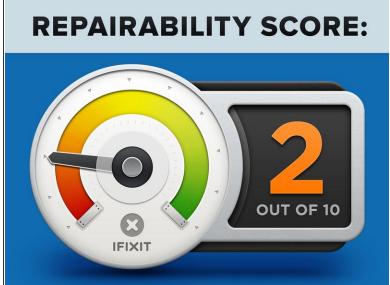
- HTC One M8 Repairability Score: 2 out of 10 (10 is easiest to repair)
  - It's very difficult—although no longer impossible—to open the device without damaging the rear case. This makes every component extremely difficult to replace.
  - The battery is buried beneath the motherboard and adhered to the midframe, hindering its replacement.
  - The display assembly cannot be replaced without tunneling through the entire phone. This
    makes one of most common repairs, a damaged screen, very difficult to accomplish.
  - Copious amounts of tape, adhesive, and copper shielding make many components difficult to remove and replace.
  - Solid external construction improves durability.
