# Xbox One Kinect Microphone Replacement

Written By: Charles Schoonover

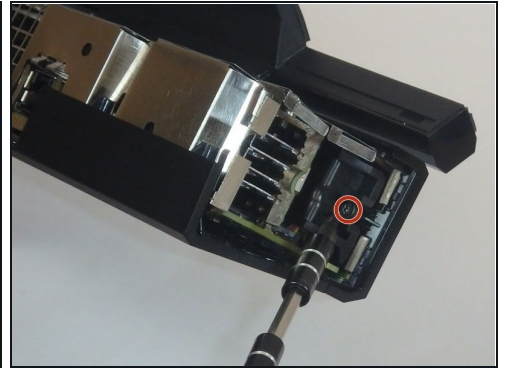
## Step 2

- Remove the back panel.
- Remove the black panels on either side of the Kinect, and remove the 3.1x7.5mm T10 screws underneath them.
