iRobot Roomba 560 Fan Replacement

Replace the fan inside of the Roomba 560's vacuum bin.

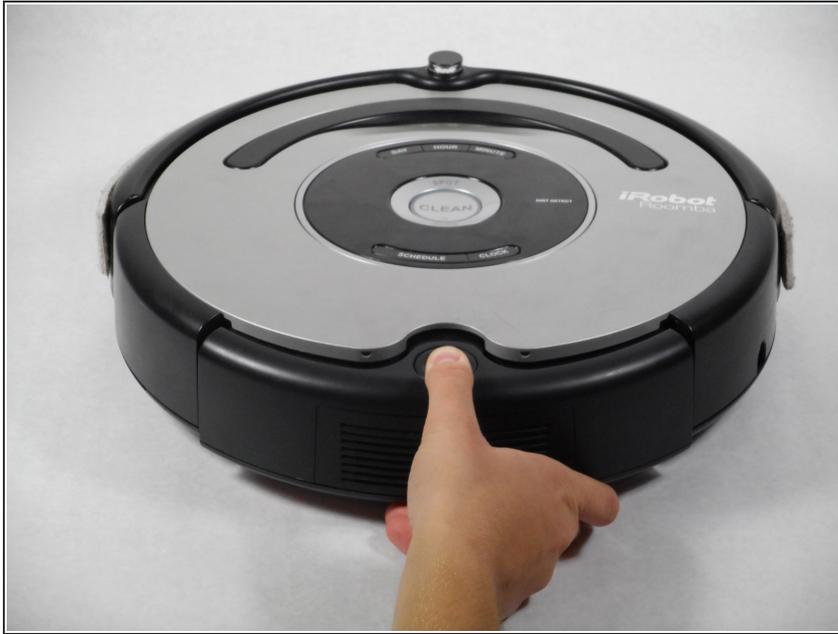
Step 1 — Fan

- Press the black circular button on the back end of the Roomba and pull the bin out towards you to remove the vacuum bin.

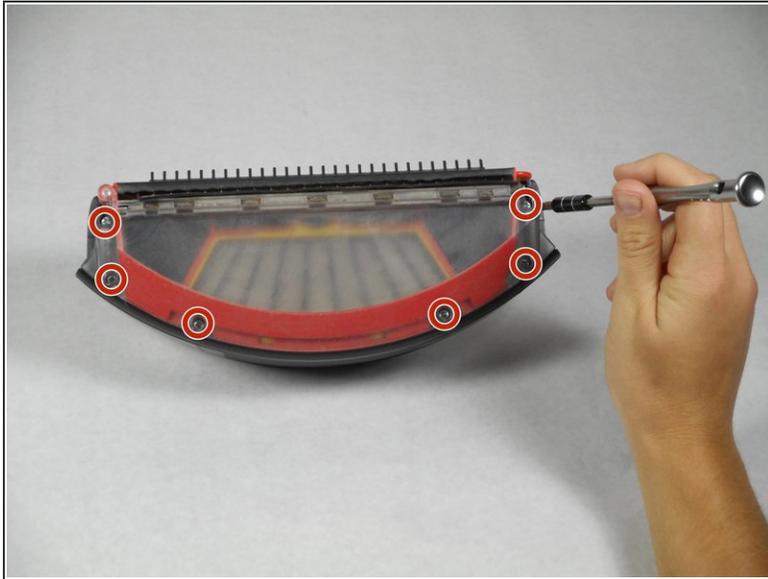
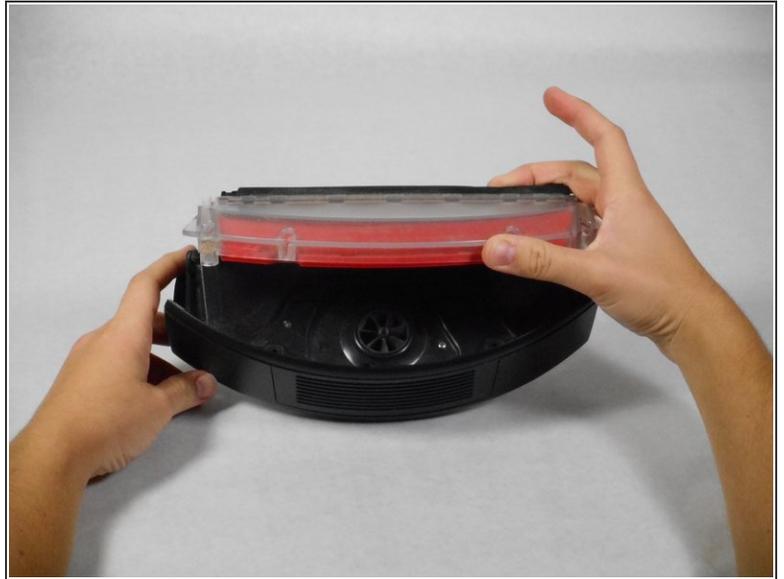
Step 2

- Lay the vacuum bin down and remove the six 15 mm screws around the outside of the vacuum bin using the Phillips JIS #1 driver.
- Remove the top of the vacuum bin by pulling it straight up.
 - ⚠ The bin is composed of two parts (the clear top casing and the red bottom filter). To avoid a mess, be careful to not let these two pieces detach, unless over a trash bin.

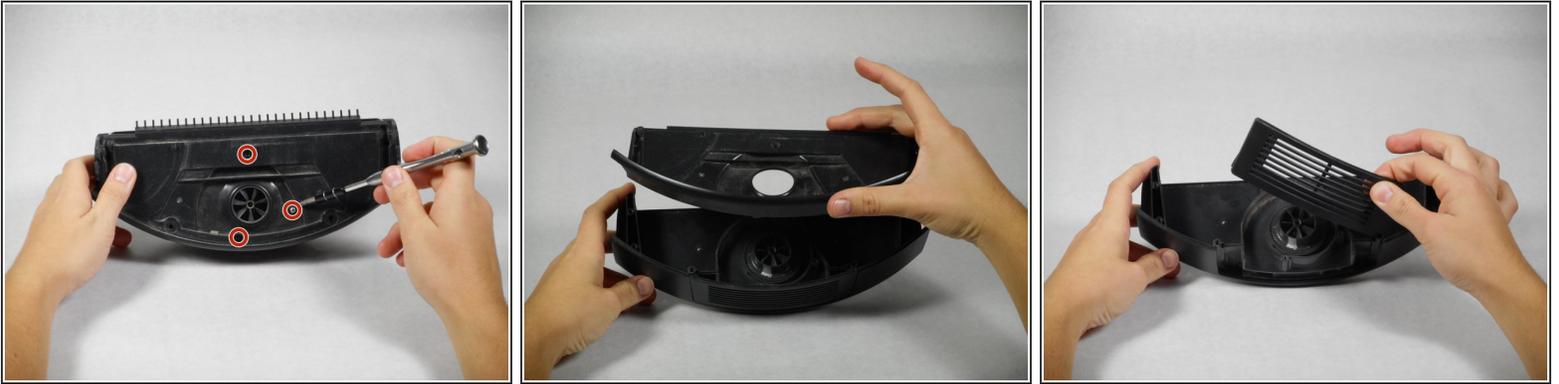
Step 3

- Remove the three 10 mm screws that surround the fan using the Phillips JIS #1 driver.
- Remove the casing that surrounds the fan by pulling it straight up.
 - ⓘ The casing is composed of 2 parts (the large top casing, and a small air filter). If these parts detach, they are very easy to put back together. Do not lose the air filter.

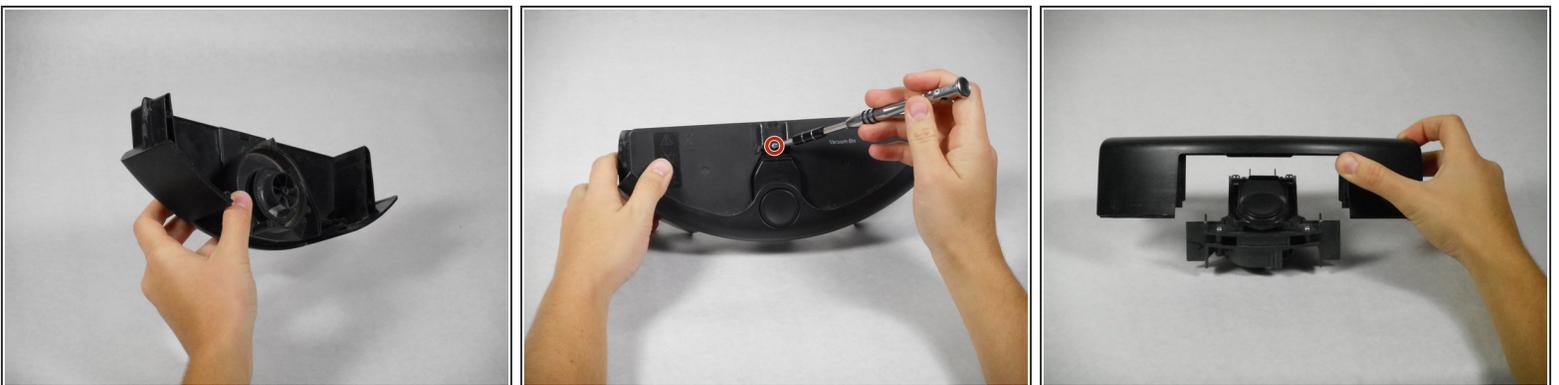
Step 4

- Turn over the remainder of the fan casing and remove the single 15mm screw, using the Phillips JIS #1 screwdriver.
- Remove the casing from the fan and battery component by pulling it straight up.

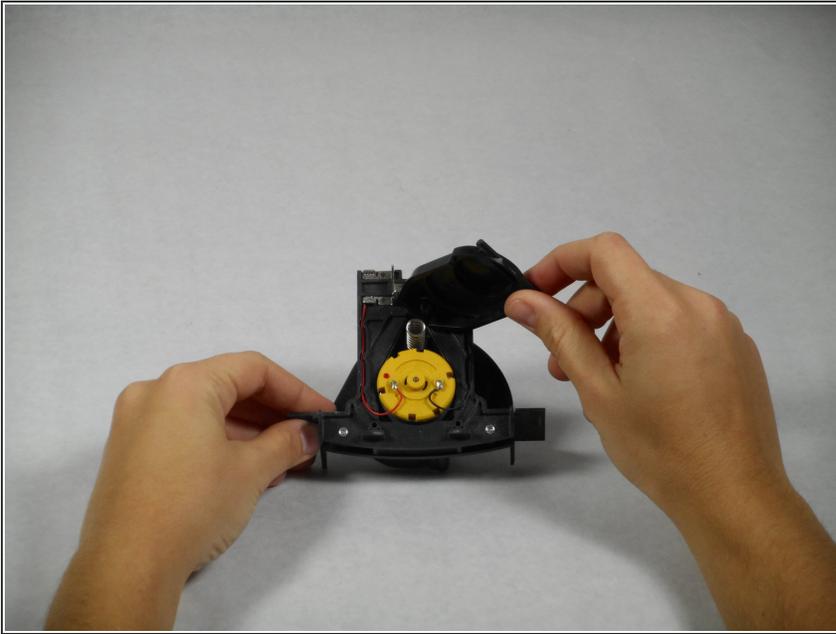
Step 5

- Remove the small black button from the top of the battery.
- ⓘ Save the spring and the button cover. The remainder of the fan assembly (yellow motor and the black housing) will need to be replaced as a unit.
